# Restoration Highlights

No. 3, February 2012

### A Geomorphic Restoration Approach for Steelhead Habitat in an Incised System with Floodplain Loss

W. Barry Southerland, Ph.D.  
Fluvial Geomorphologist, CPESC#514  
WQQT-West National Technology  
Support Center  
USDA-Natural Resources Conservation  
Service

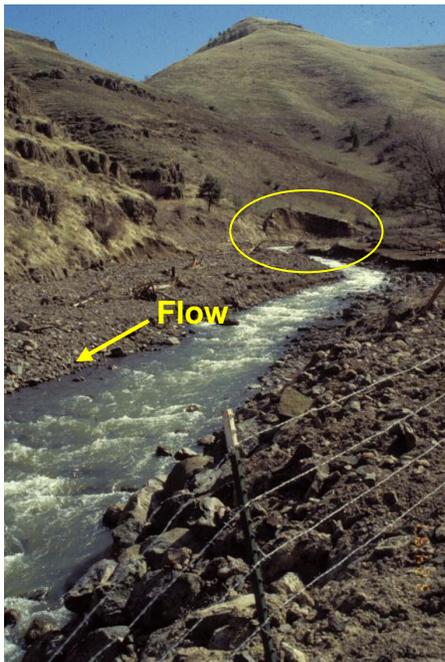
Figure 1. Post flood damage, 1996.

winter feeding operations and to protect their hayshed and a county bridge. During the high flow event of 1996, a colluvial mass wasting event<sup>1</sup> shifted the stream towards left bank (downstream orientation) threatening the wintering hayshed with a high likelihood of flanking the bridge.

In 1997, a priority 3 type geomorphic restoration was designed and implemented to address: floodplain re-establishment, bedload transport, steelhead habitat, native riparian plant community, and re-alignment with the county bridge. A priority 3 type restoration is characterized by using tall incised banks to rebuild both the floodplain and bankfull channel. The correct dimension, pattern, and planform have to be designed to meet the goals of natural channel stability and restoration.

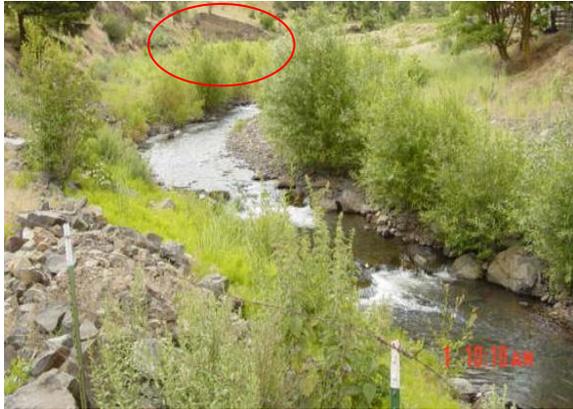
**Figure 2. View of meander, five years after reconstruction.**

- Dimension, pattern, and longitudinal profile have remained stable and consistent with no discernible signs of accelerated streambank erosion.

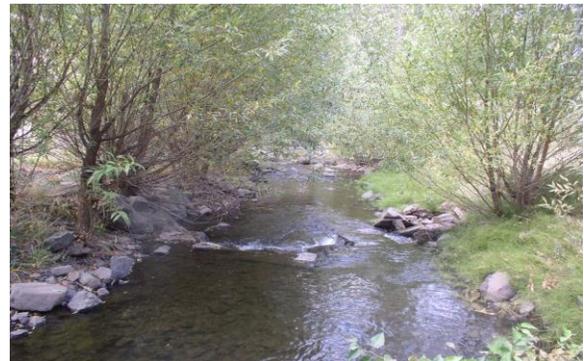
**Figure 3. In 2006: ten years and four floods after reconstruction.**
