Ecological Restoration in Flanders

Mededelingen van het Instituut voor Natuur- en Bosonderzoek INBO.M.2008.04

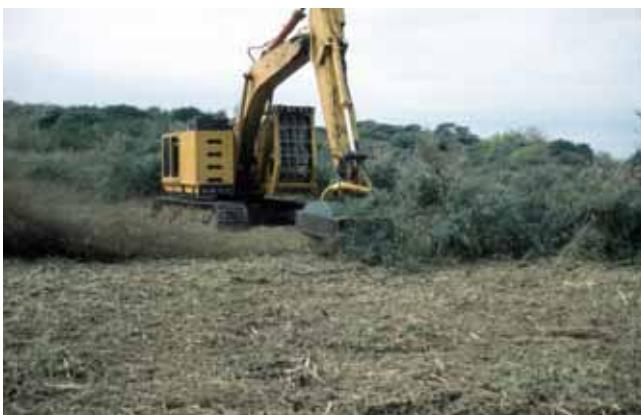
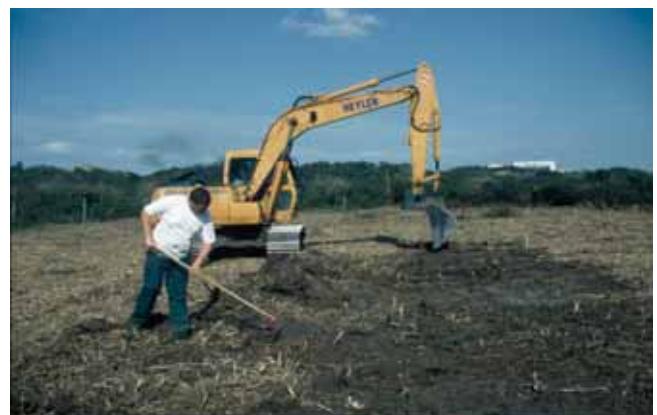
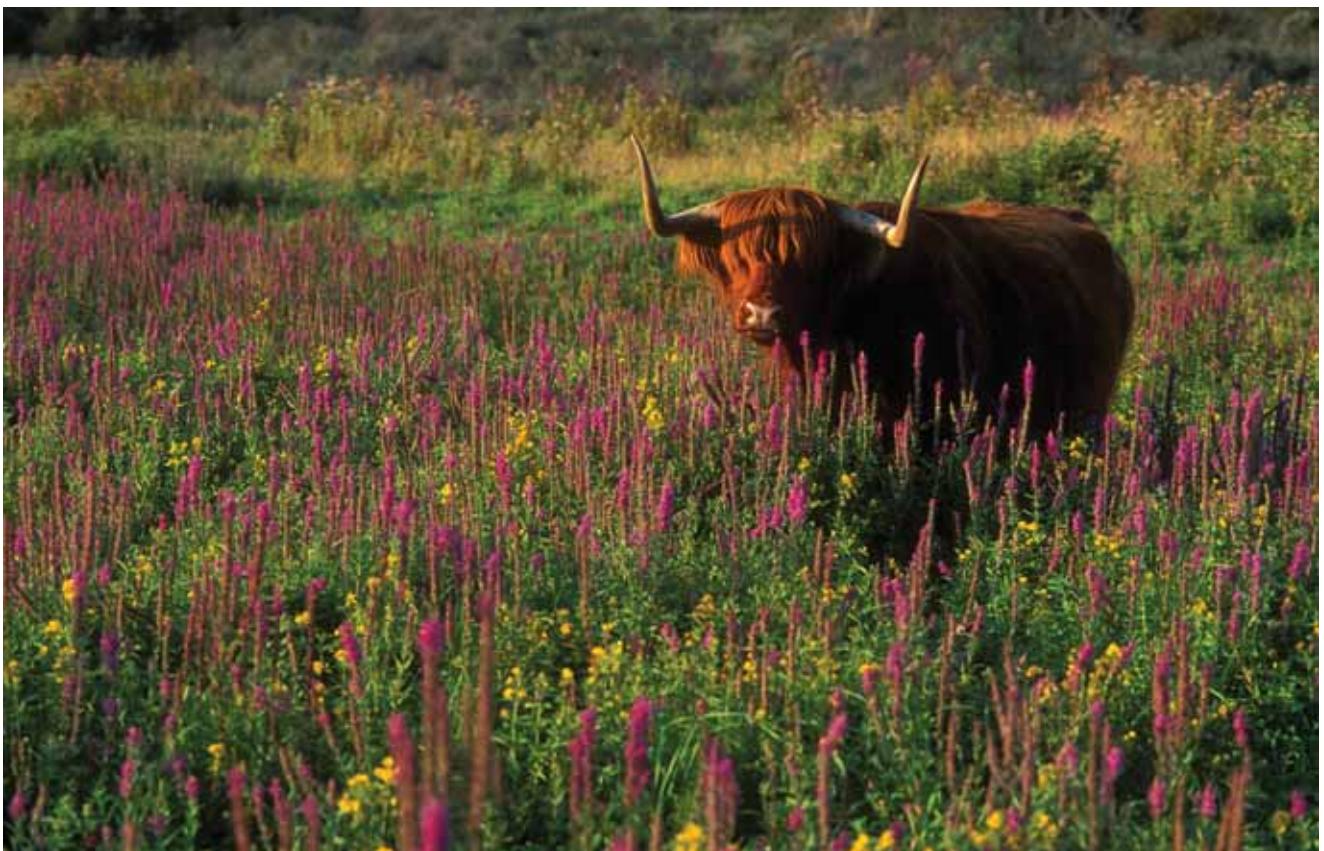
Removal of scrub and litter layer for the restoration of dune grasslands and the results after a few years...

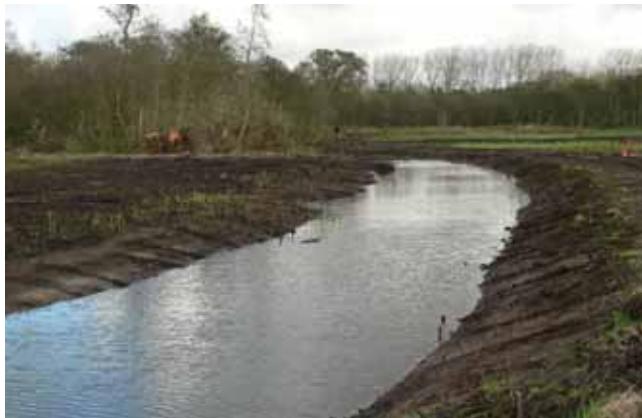
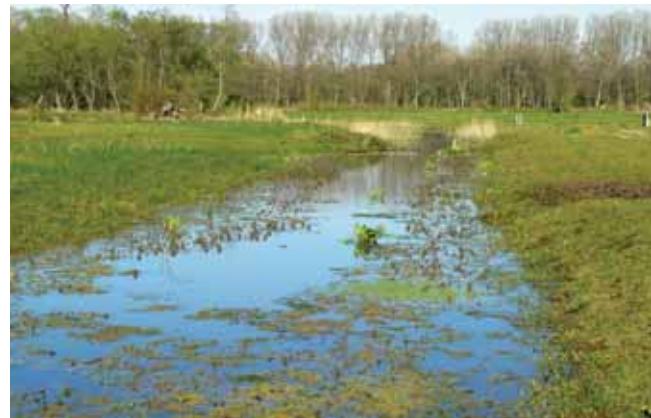
A unique dune brook for the Belgian coast was dredged and reshaped, with return of e.g. *Characeae* vegetations and *Groenlandia densa* as a result.

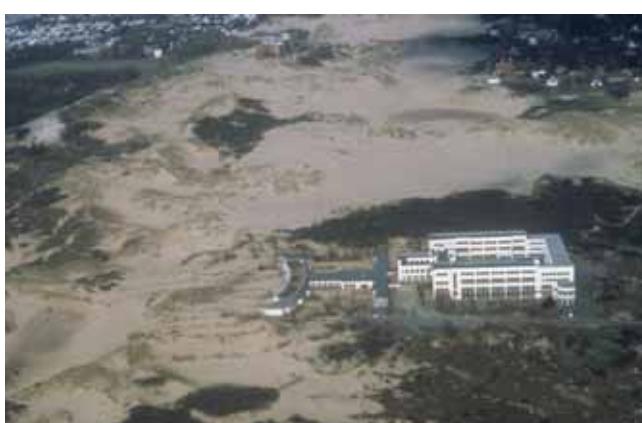
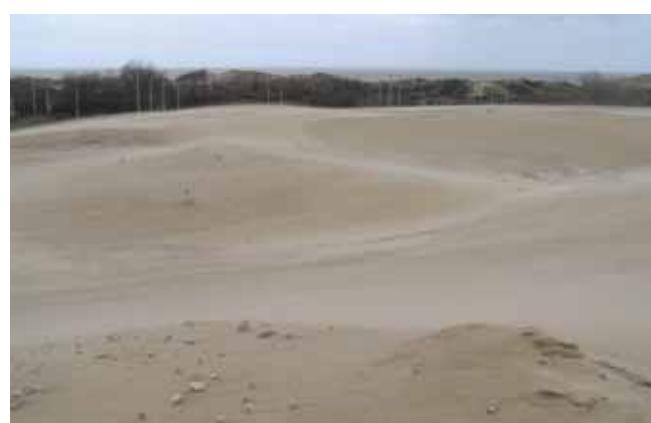
"Home G. Theunis" was the first large building in Flanders that was removed for the purpose of ecological restoration (1995). After removal of debris the site was restructured into a natural looking parabolic dune with renewed geomorphologic dynamics.

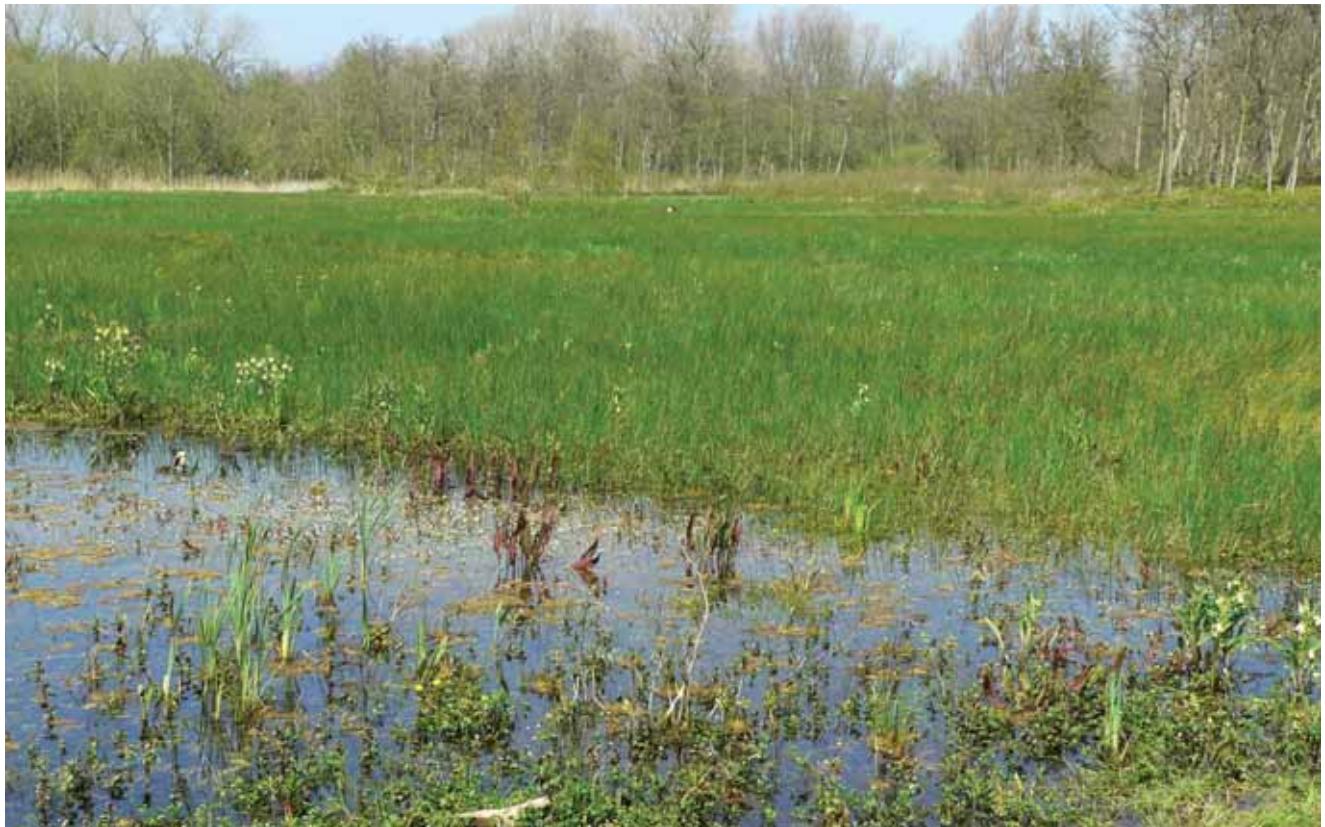
Part of Hannecartbos, an alder afforestation on wet peaty dune soil, was cleared, resulting in a spectacular return of numerous target plant species from the seed bank.

- Although a preceding seed bank survey did not reveal many interesting species, the good results of the woodland clearing are mainly caused by species most probably emerging from the seed bank (*Anagallis tenella*, *Blysmus compressus*, *Carex panicea*, *Potamogeton coloratus* etc.).

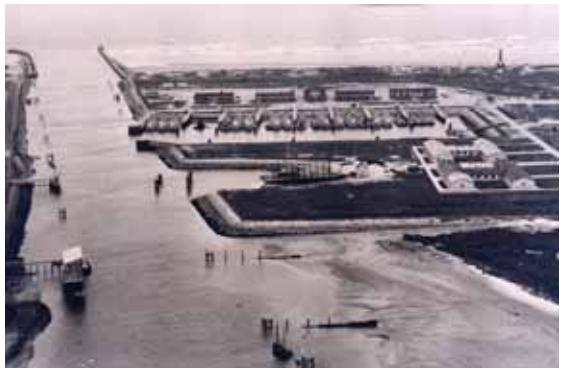
The IJzermonding restoration project is certainly one of the most impressive restoration projects in Flanders up till now. An old marine base was dismantled and more than 400,000m³ of raised ground was removed. Aerial overview in 1957 and 2006.

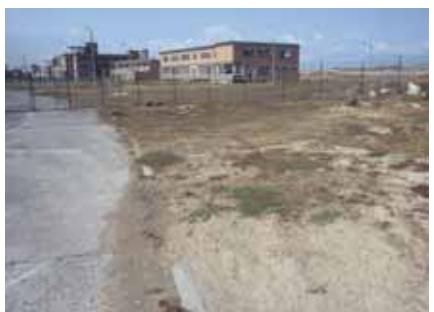
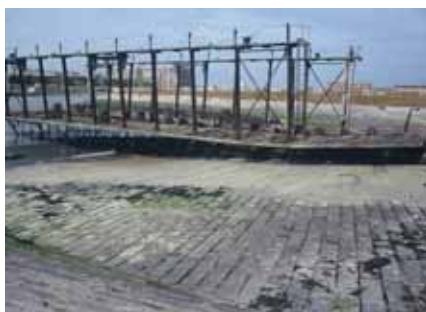
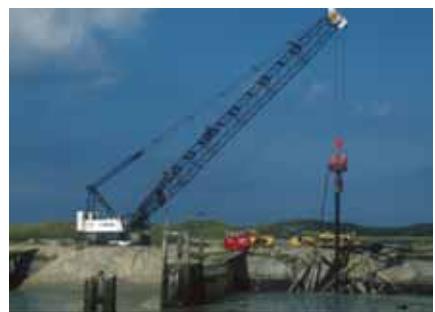
Some details of the disused marine base and the heavy equipment that was necessary to restore the area.

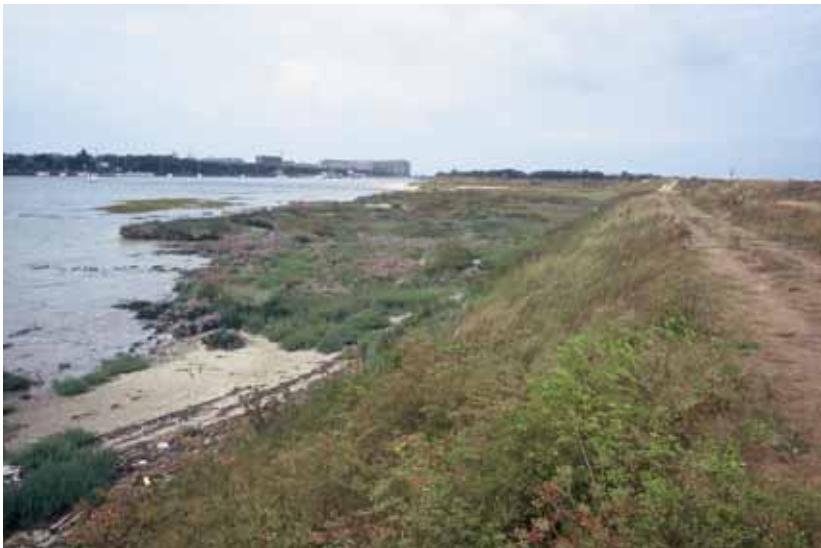
Small remnant of the original salt marsh (left) and the salt marsh raised with sludge from the fairway of the river IJzer (right) before the start of the restoration works.

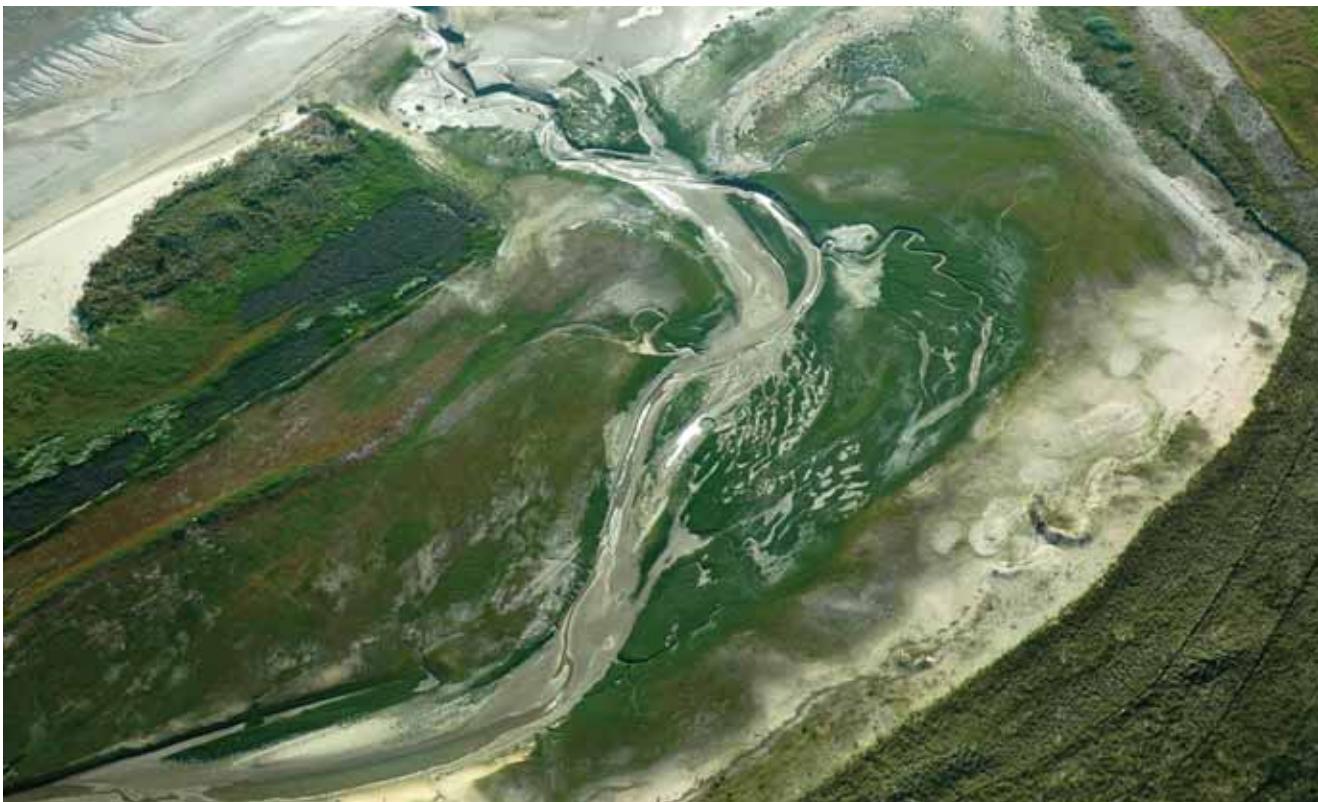
Aerial photo of a part of the restored salt marsh area after 4 years of spontaneous succession (2006). Note the part of the original salt marsh that was never raised in the upper left corner.

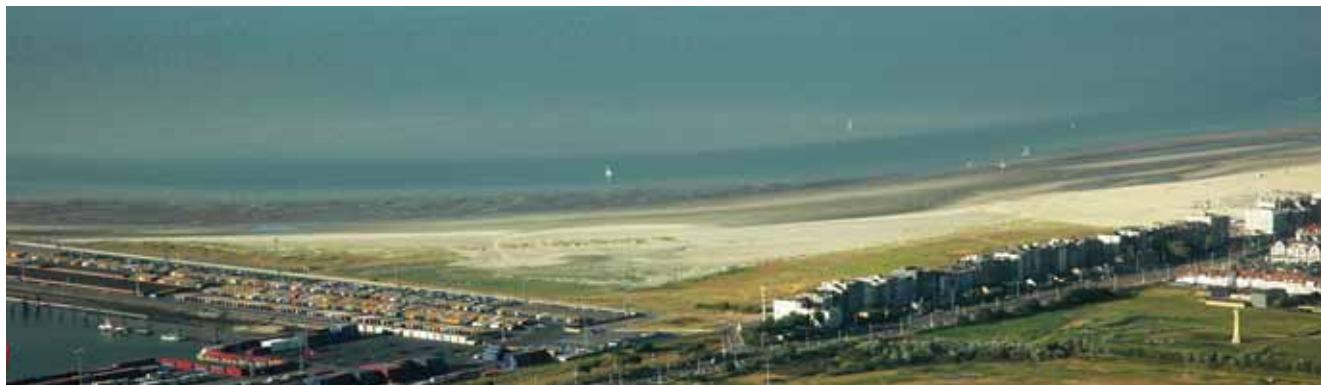
Aerial photo of the Baai van Heist (July 2006).

As a result of its recent history, the area is highly dynamic. In the northern corner of the beach strong erosion took place in the period 1986-1990. After a period of accretion (1998-2005) strong erosion occurred in the north-western corner of the beach (2005-2008), while a sand bank is steadily growing in the shallows in front of the beach. This sand bank isimmerged every high spring-tide. The central beach part is the most dynamic zone. The level has risen and a 'bay' has developed in the past decades. The former central depression at the beach is almost completely filled with sediment originating from hydrodynamic and aeolian processes. In the natural embryonic dunes in front of the sea dike and harbour groyne sand fixation occurs. *Elymus farctus* primarily fixates the sand and later in this process embryonic dunes are formed. Especially interesting are the halotolerant vegetations of the numerous tidal gullies in between the embryonic dunes. The occurrence of *Ammophila arenaria* at some of the embryonic dunes indicates the presence of a freshwater environment. In these areas, a direct evolution from *E. farctus* vegetation to 'grey dune' vegetation occurs.

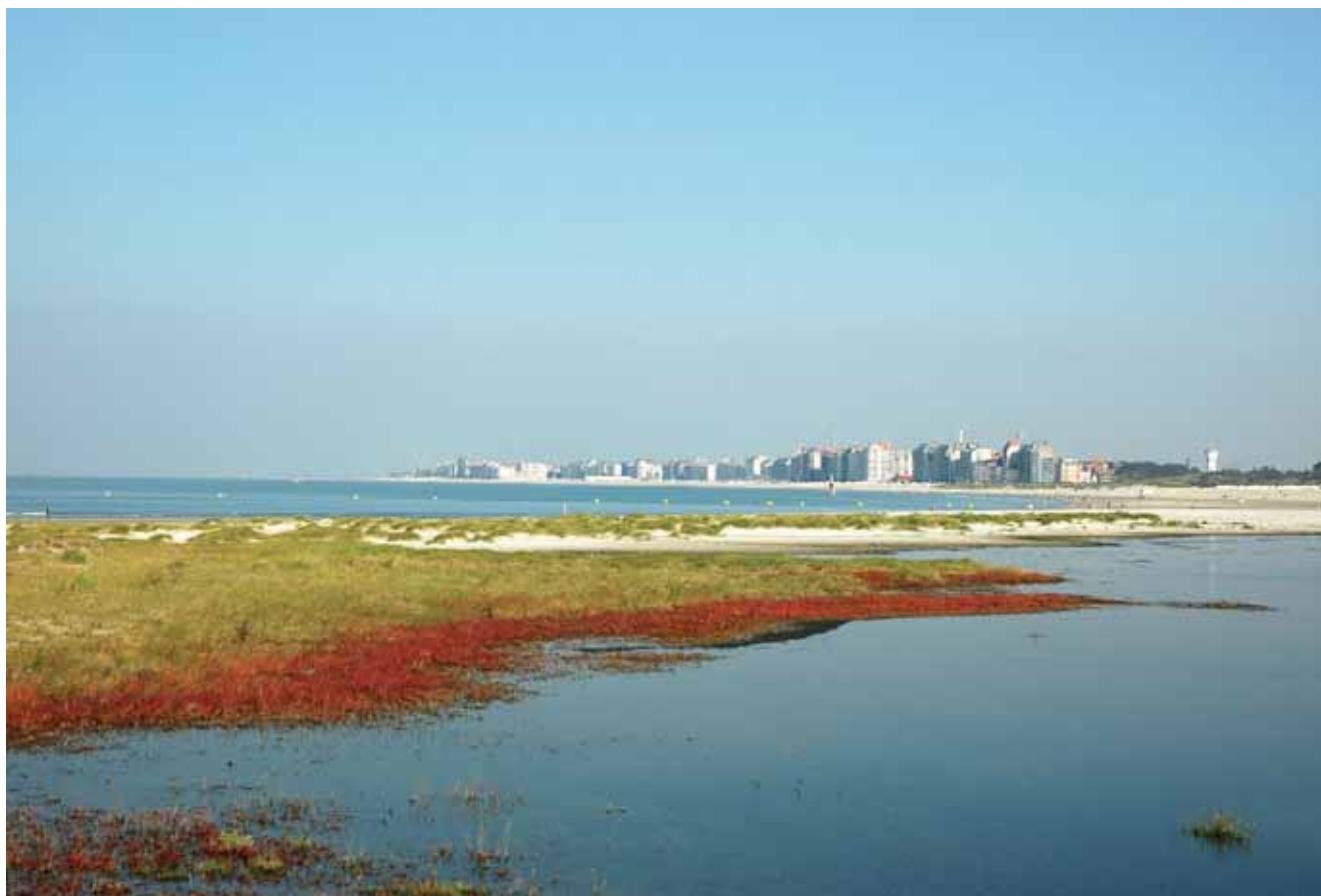
Autumn impression of *Salicornia* vegetation and embryonic dune formation in the Baai van Heist.

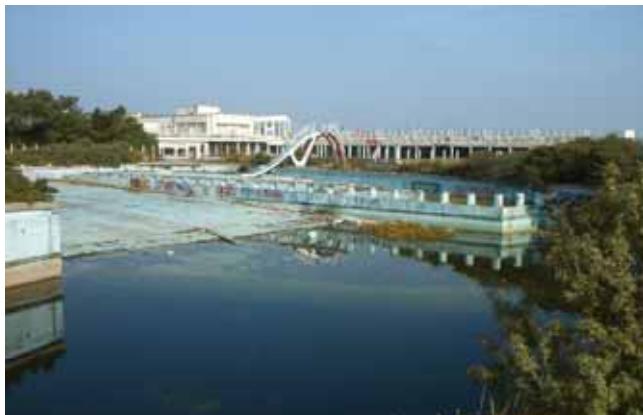
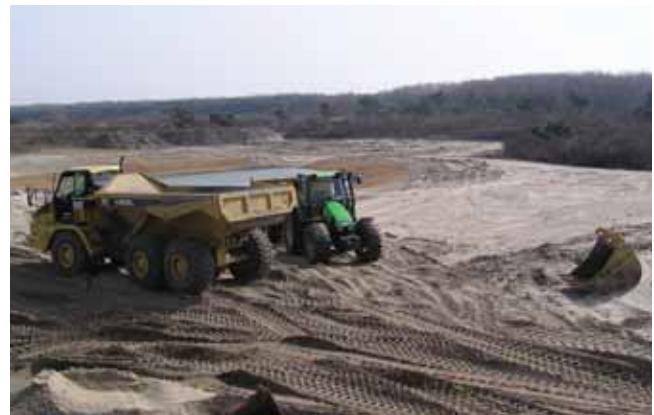
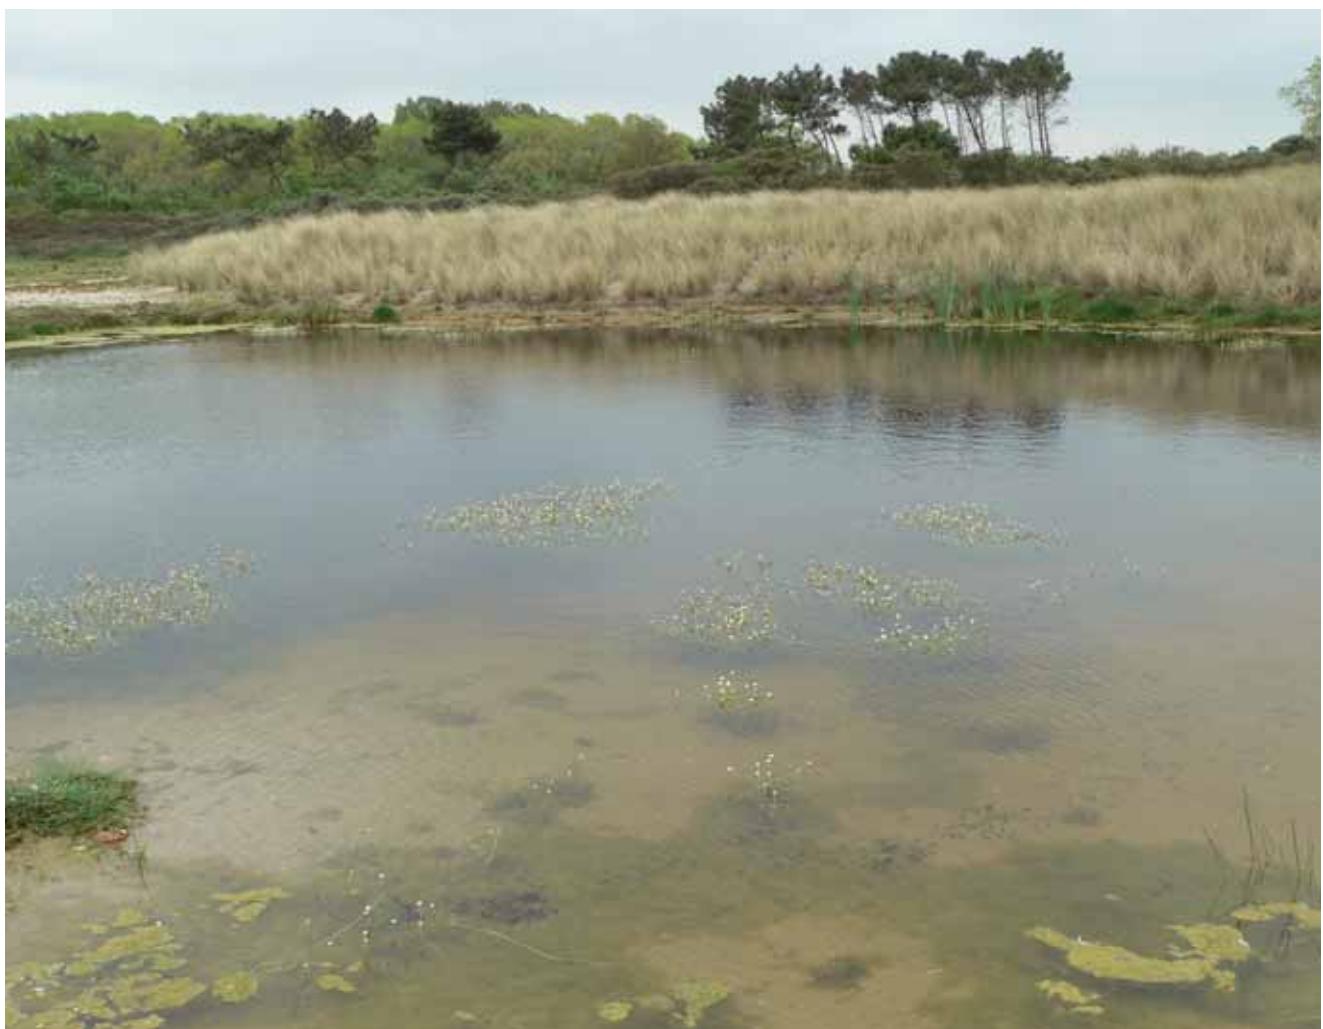
In 2004 a disused swimming pool site was transformed into the original dune grasslands, dune slacks and a large dune pond. Two years later the newly created pond already showed an interesting water and bank flora and aquatic fauna.

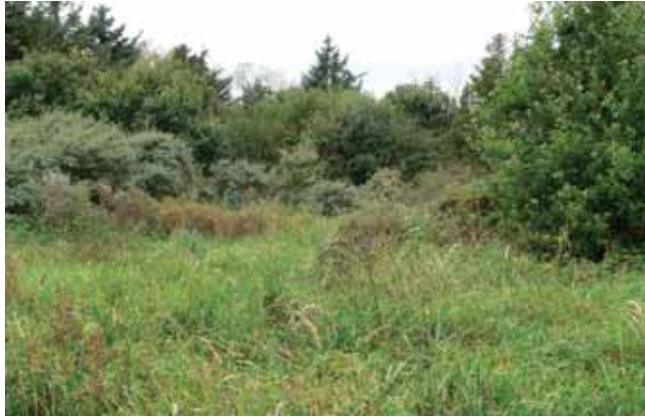
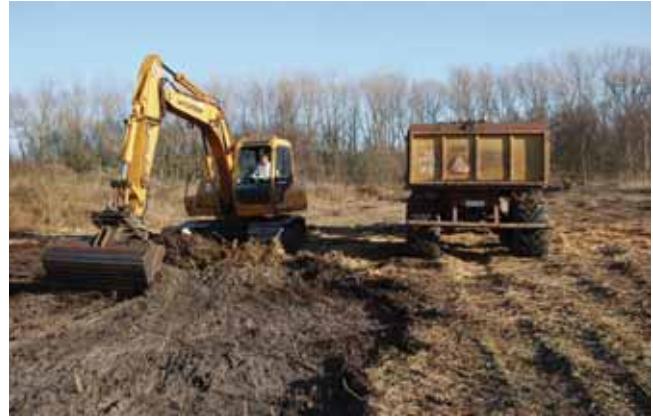
Removal of invasive scrub and sod cutting works for the restoration of moist dune slacks.

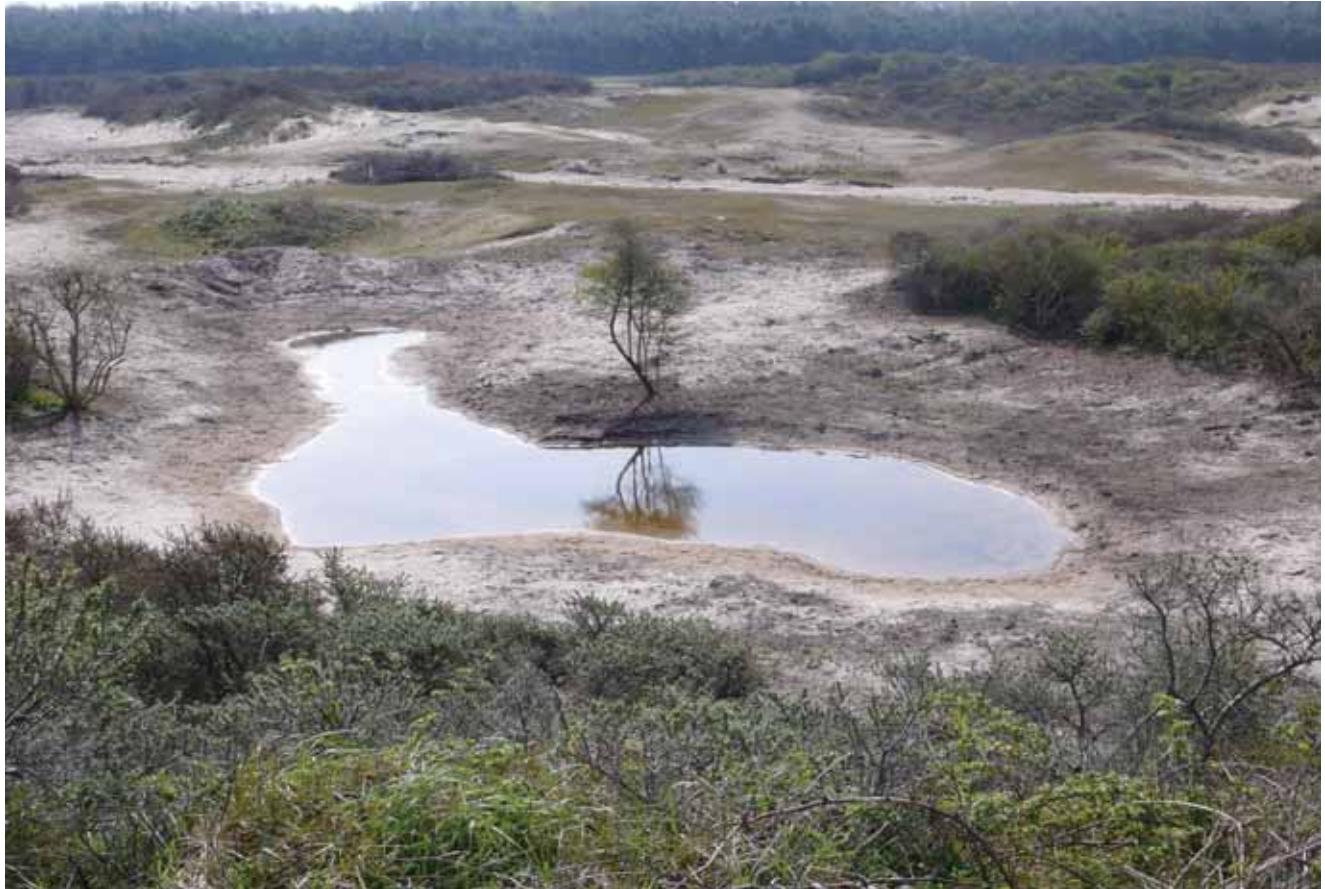
Newly created drinking pool in the northern, grazed part of the area.

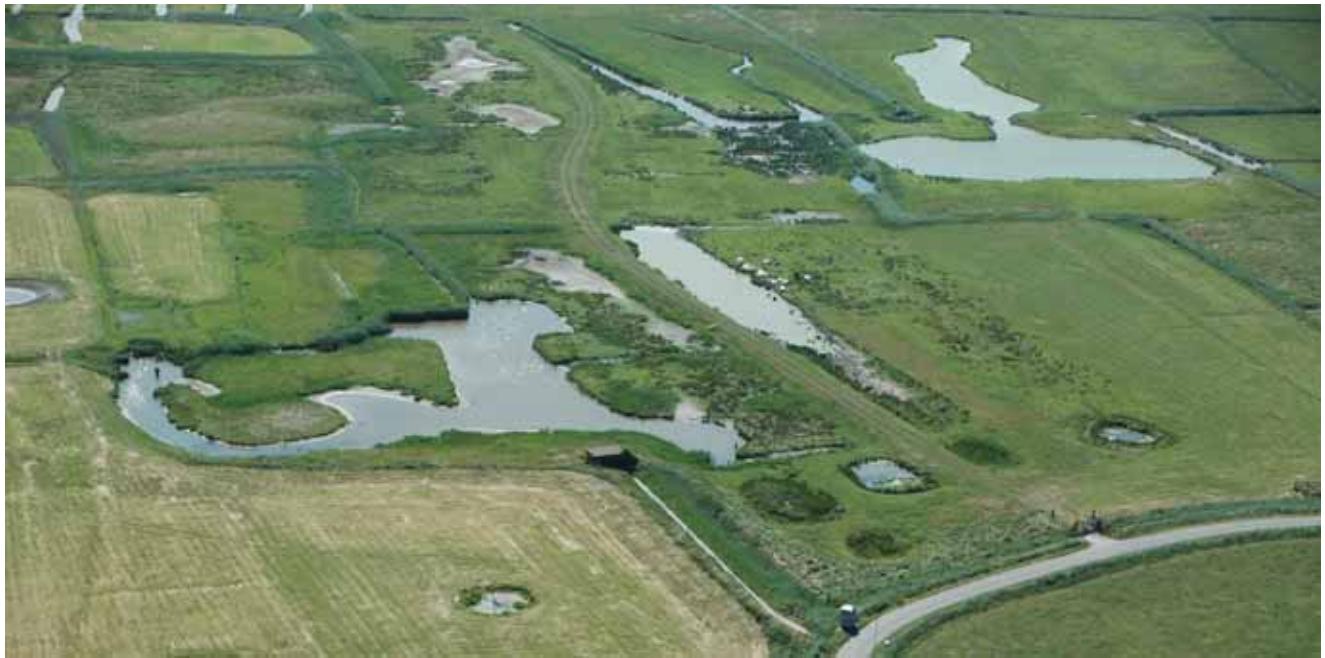
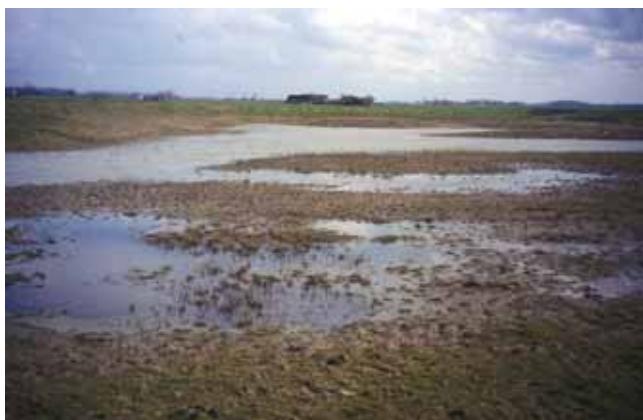
Large parts of the ancient polder grasslands with salt meadow relics in the Uitkerkse Polder were raised and levelled for agricultural purpose. The aim is to gradually restore the historical micro-topography and ditch pattern of this unique landscape. At some places new pools and depressions with both salt or brackish water were created as well.

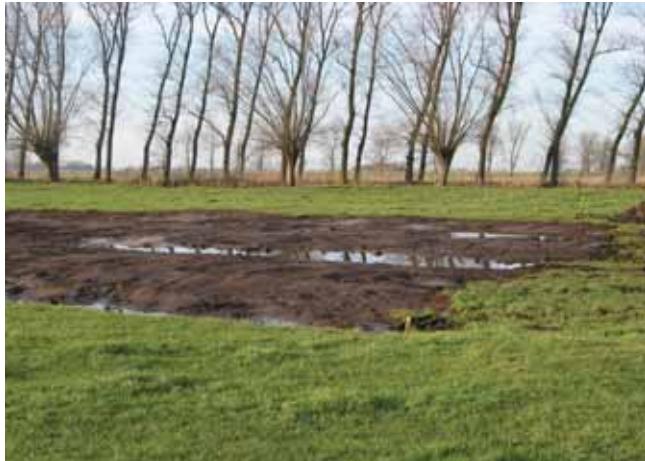
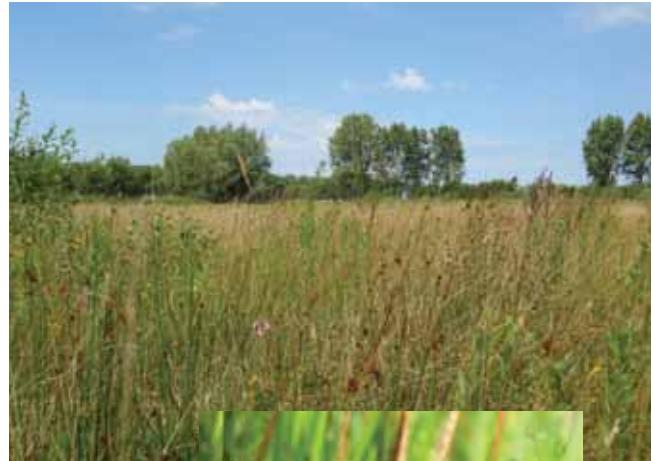
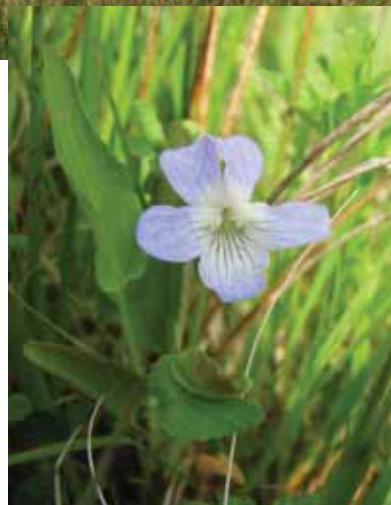
Experimental top soil removal of intensively used agricultural grasslands in the Meetkerke Moeren yielded unexpected results. *Viola persicifolia* had not been seen in Flanders for more than 130 years until it reappeared here from a seed bank. It proves the value of an experimental approach and close monitoring to enable appropriate planning of a large-scale restoration project.

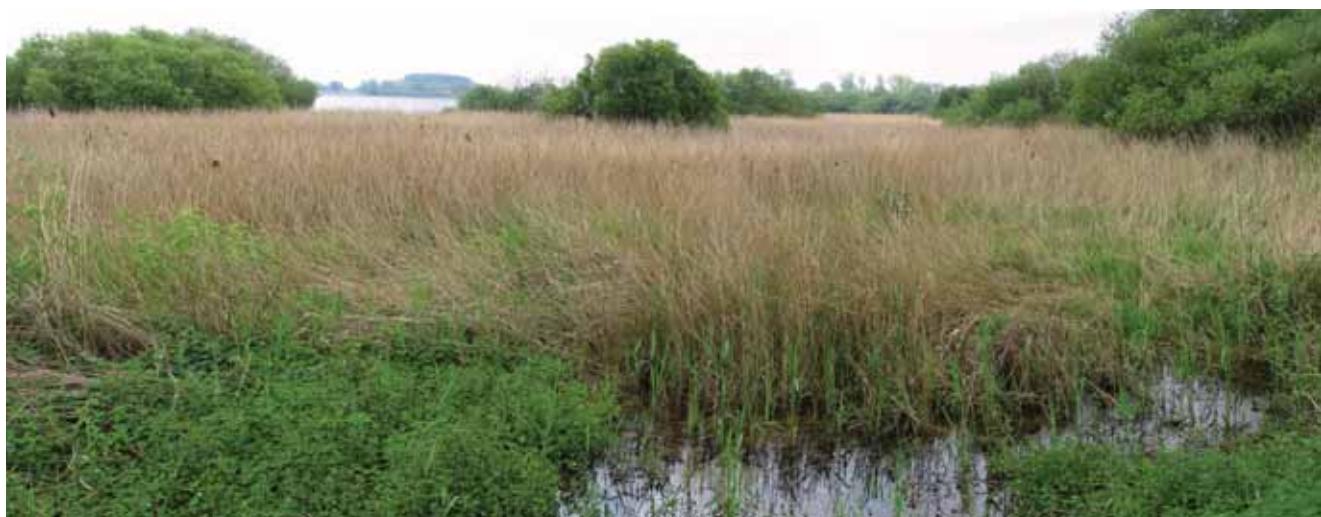
As a result of the lowering of the water table in its surroundings the reedmarsh of lake Blankaart (background) has been invaded by *Urtica dioica* and willow scrub (foreground).

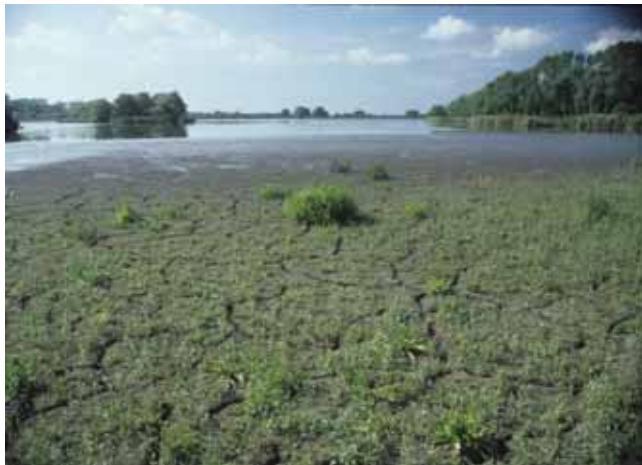
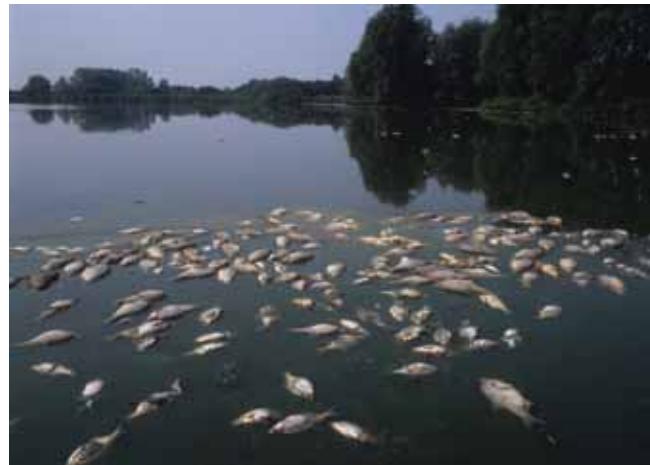
In the 1980s lake Blankaart completely silted up with sediment from field erosion in the catchment area of its inflowing rivulets and periodically dried out, with massive fish mortality as a result.

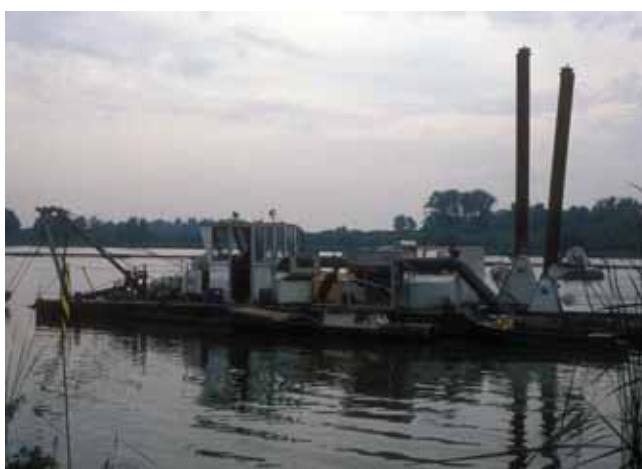
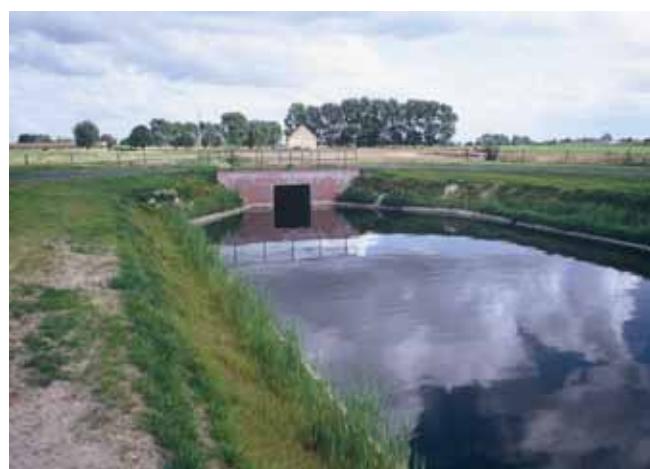
An attempt in 1994-1995 to restore the lake ecosystem (once full of submerged and floating macrophytes) by large-scale dredging (left) and the building of sediment traps on some of the inflowing rivulets (right), failed. The lake remains hypertrophic as a result of still ongoing nutrient and sediment inflow from the surrounding agriculture. Measures at the source of the problems are needed.

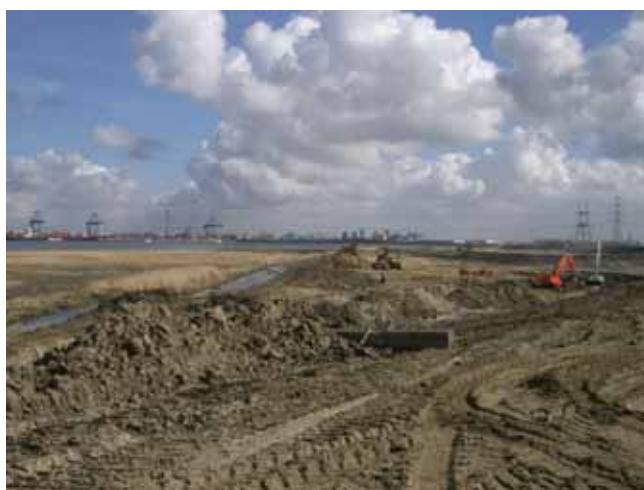
Restoration of 12 ha of brackish tidal marsh and mudflats at the Paardeschor along the river Schelde, as a compensation measure for the expansion of the port of Antwerp. On the orthophoto the existing part of the marsh is noticeable in the upper left corner. Yellow dots indicate the monitoring plots.

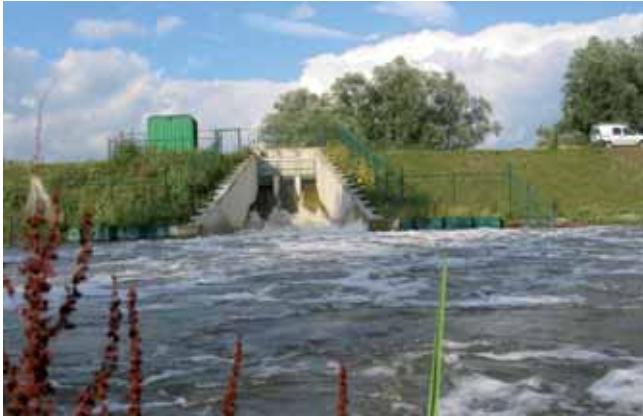
Detail of the inlet sluices in the dike during flood when water is entering the FCA-CRT Lippensbroek.

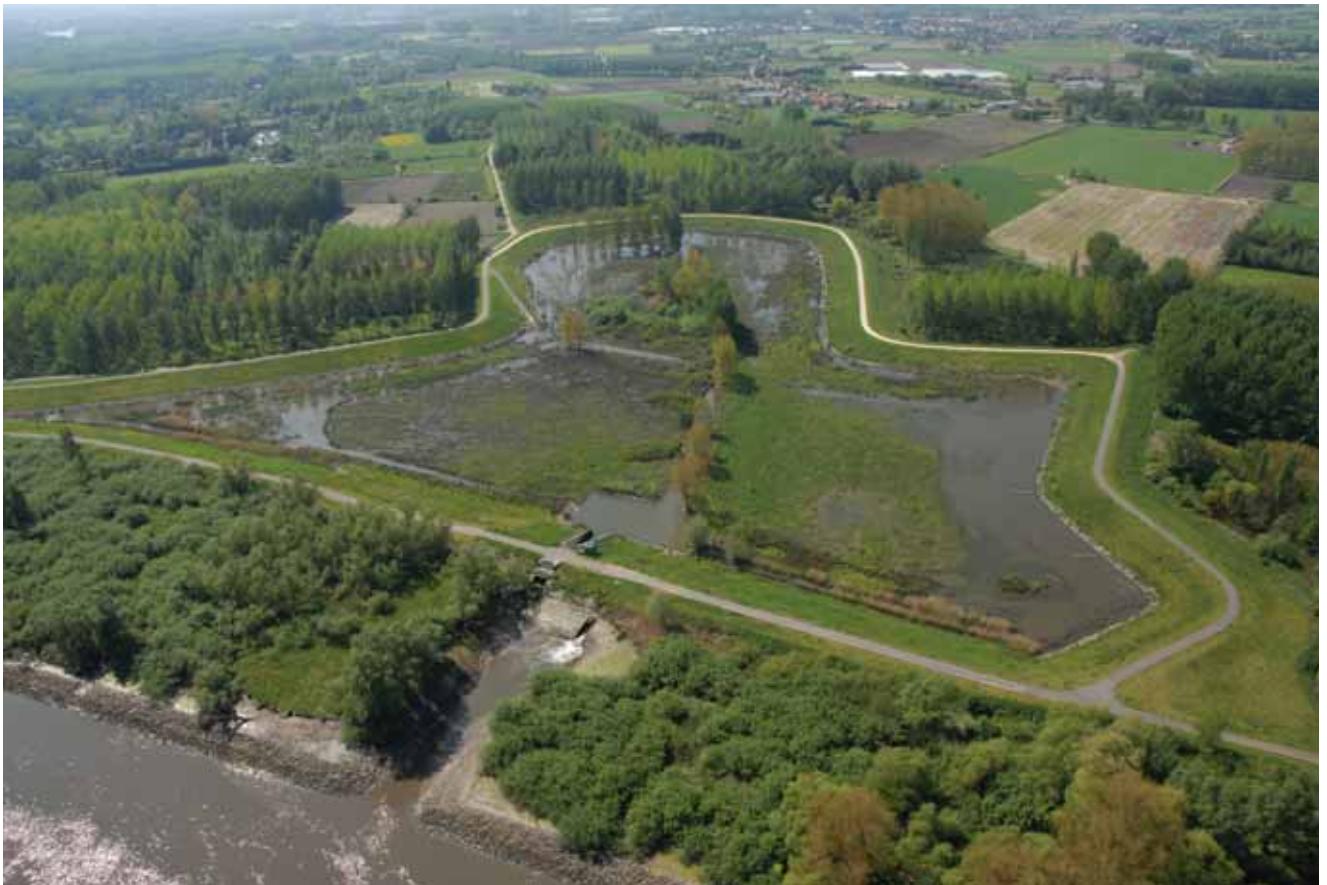
Aerial view of the 10ha large FCA-CRT Lippensbroek during ebb.

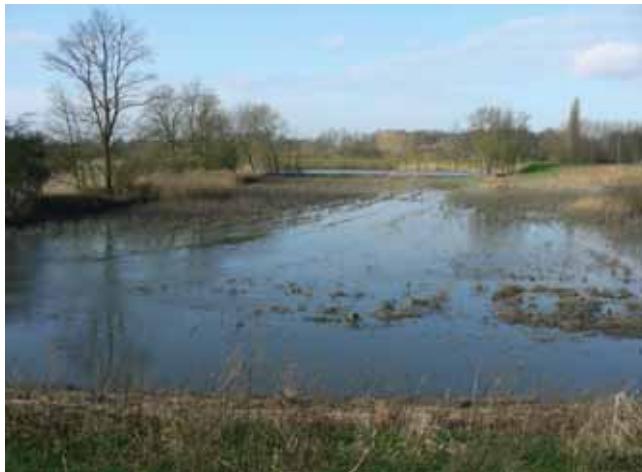
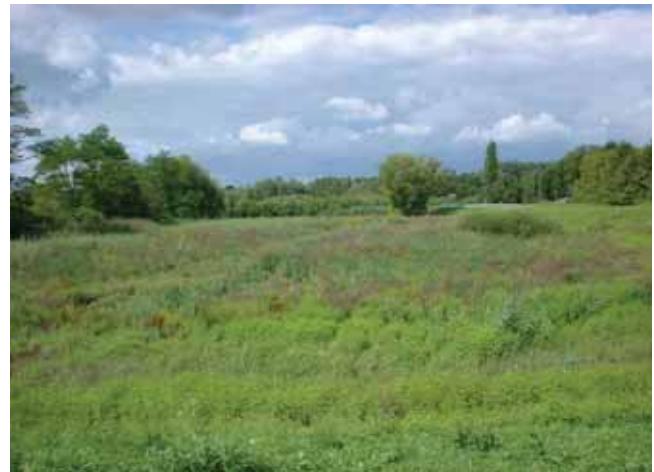
Part of Heusden LO (10ha) during flood in winter (Feb. 2007) and the same area covered by pioneer vegetation of *Polygonum hydropiper* and *Lythrum salicaria* in summer (Aug. 2007).

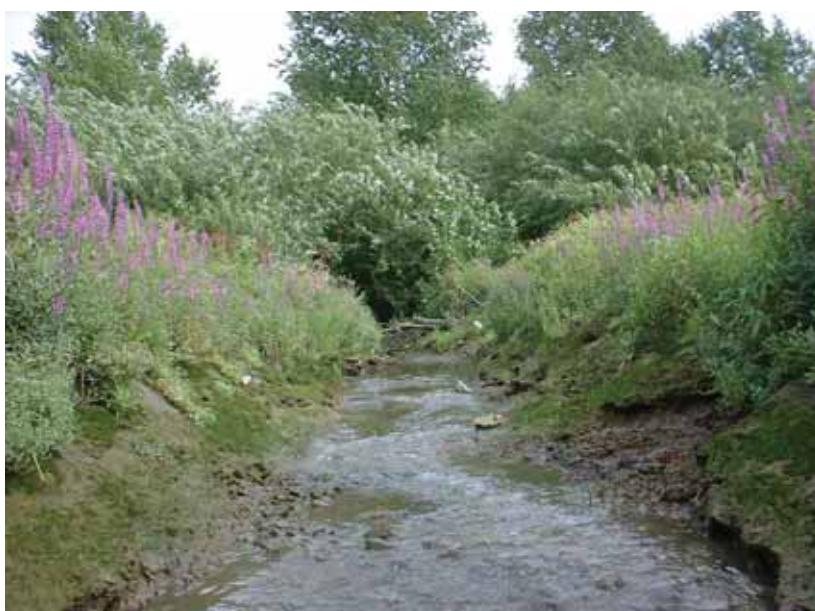
Detail of the breach to mean low water level in Heusden LO where an old sluice used to be.

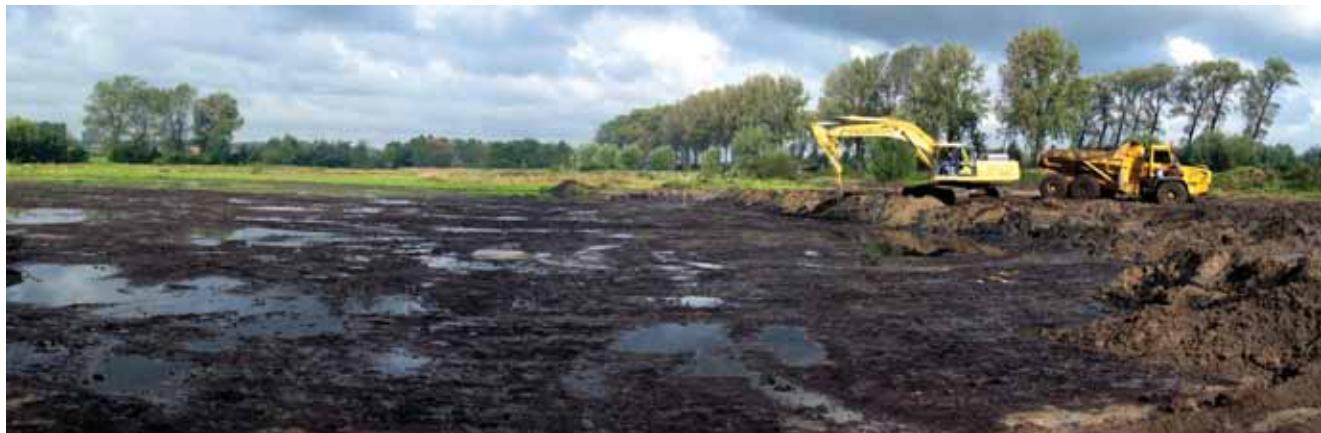
Removal of the sludge down to the original peat soil.
