Restoration Walks 2013

Olympic Sculpture Park Beach

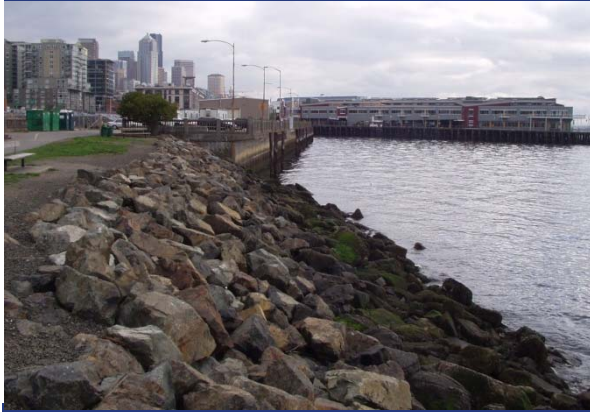
Pre-Project Conditions

Seattle's downtown waterfront is part of Elliot Bay and the Green/Duwamish River Estuary. The shoreline is officially critical habitat for Chinook salmon, federally listed as threatened under the Endangered Species Act. The project's pre-construction shoreline typified poor habitat conditions for out-migrating juvenile Chinook salmon and the species they depend on. These conditions included: an abundance of deep water, ideal for salmon predators, and an absence of food resources.

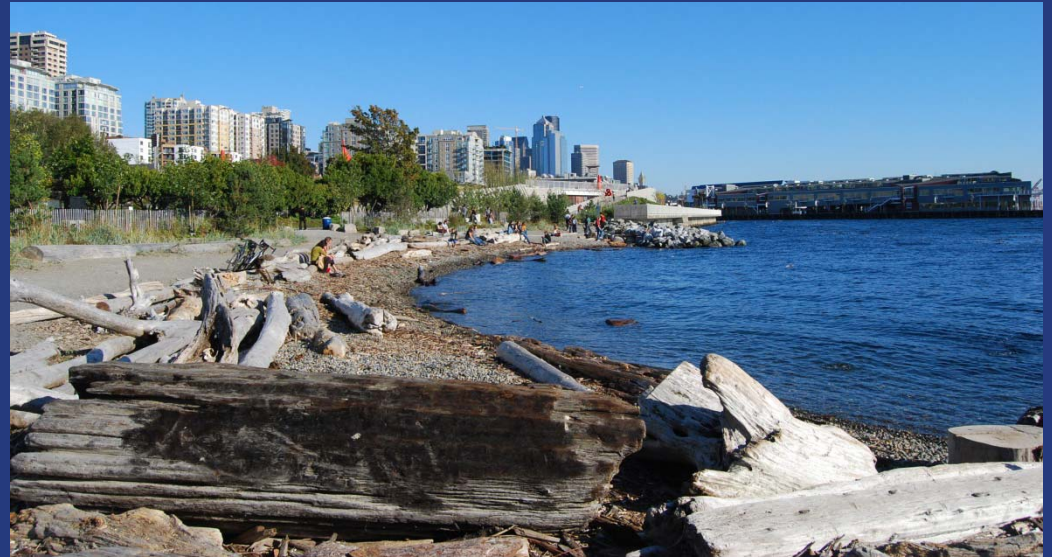
The combination of the 1,200-foot-long habitat bench and the pocket beach are the most significant improvements to salmon habitat ever attempted in downtown Seattle. Prior to development as a major urban center, Seattle's Puget Sound shoreline consisted of continuous intertidal beaches. The project restores all the habitat zones originally found in the area including: a marine riparian zone consisting of native trees and shrubs, a sandy "backshore" beach with native beachgrass and naturally accumulating driftwood, a gravel "foreshore" beach that absorbs high energy storm waves, a low tide terrace (habitat bench), and subtidal "kelp forest" zone colonized by a variety macroalgae species such as bull kelp. The Seattle Art Museum formed partnerships with the Seattle Aquarium to conduct educational programs at the shoreline and conduct beach cleanups. Scientifically rigorous biological monitoring of the habitat was conducted by the University of Washington.
