Restoration Highlights

No. 6, October 2013

Elwha Ecosystem Restoration Project: Natural and Managed Revegetation in the Drained Reservoirs after Two Growing Seasons

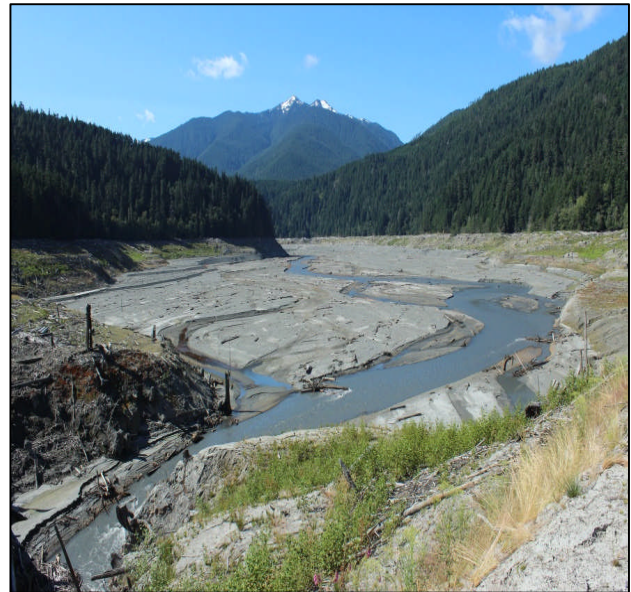
Figure 1. View of the former Lake Mills reservoir (July 11, 2013). There is still 50 ft of dam left, so the river in its current location is 40-50 ft above the original valley bottom.

The historic dam removal on the Elwha River, the largest of its kind in the country and possibly the world, is nearing completion. The 108' tall Elwha Dam, completed in 1913 and located at river mile 5, is no more; full removal was accomplished in the spring of 2012. The 210' tall Glines Canyon Dam, completed in 1927 and located at river mile 13, was reduced to 50' tall as of November 1, 2012. Full removal is expected to be completed by the summer of 2014. Despite the delay, both reservoirs formed by the dams, Lake Aldwell and Lake Mills are now only memories. The current scene is dynamic, a flow of sediment and water surrounded by gently sloping valley walls covered in ribbons of green (Figure 1).

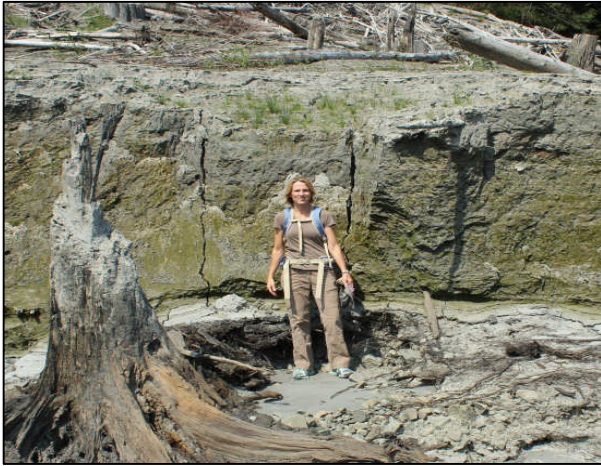
Figure 2. EWU researcher Rebecca Brown in front of a 5-6 foot deposit of silt and clay in the former Lake Mills reservoir.

reservoir floor and between 1 and 5 feet thick on the valley walls (Figure 2). This massive amount of sediment is now nearly as dynamic as the river. The coarse sediment is eroding forward toward the dam site, overtopping the thick layer of clay and silt on the reservoir floor. As of June 2013, nearly 7 million cubic yards have left the former Lake Mills reservoir. Once dam removal is completed 10-14 million cubic yards of sediment is expected to remain in the former reservoir, covering over 400 acres of historic valley bottom and slopes at Lake Mills. We expect that the texture and depth of sediment will influence species composition and overall success of revegetation efforts.

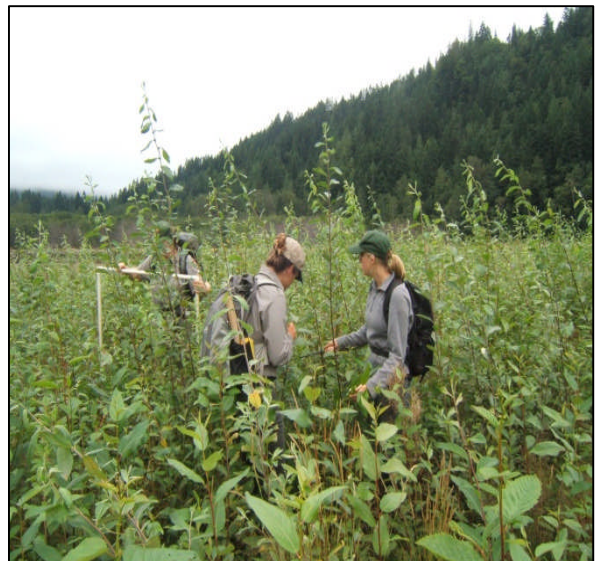
Figure 3. A dense patch of naturally regenerating willow, cottonwood and alder in Lake Aldwell, August 2012. Stem density at this site exceeds 50,000 per acre!

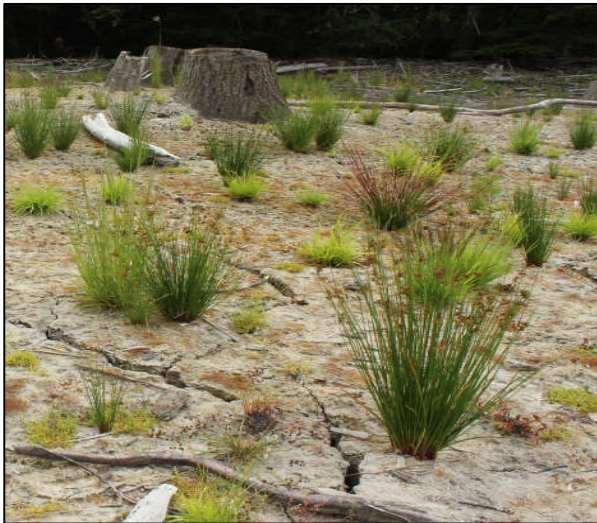
Figure 4. Natural regeneration of *Juncus* in the former Lake Mills reservoir, July 2012.

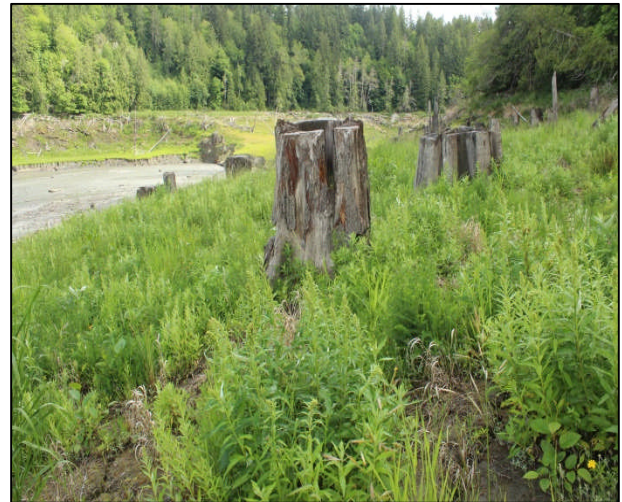
Figure 5. Forb-only seed mix seeded in March 2012 in the former Lake Aldwell reservoir. Photo taken June 2013.

The first planting season began in November 2011 and ended in March 2012. At Lake Aldwell, we conducted an herbaceous seeding trial on a 1.25 acre plot of fine sediment. The trial evaluated different mixes of grasses and forbs and two sowing rates. Everything performed exceptionally well (Figure 5). At Lake Mills we planted over 30,000 plants into newly exposed surfaces. These first plants were planted into both fine and coarse sediments. We wished them luck (no watering, weeding or mulching) and then monitored them during the growing season. As part of our monitoring program, a Master of Science student from Evergreen College, Marisa Whisman, tagged 860 plants representing five woody species. The plants benefitted from cool weather and rains at the start of June and again in early July. Mid-July
