Presentation to SERO Annual General Meeting

September 30, 2016 Mark Bassingthwaite, P.Eng.

This presentation will cover some lessons learned through several watercourse restoration projects that involved modifications to floodplains in conjunction with watercourse realignment or restoration due to erosion

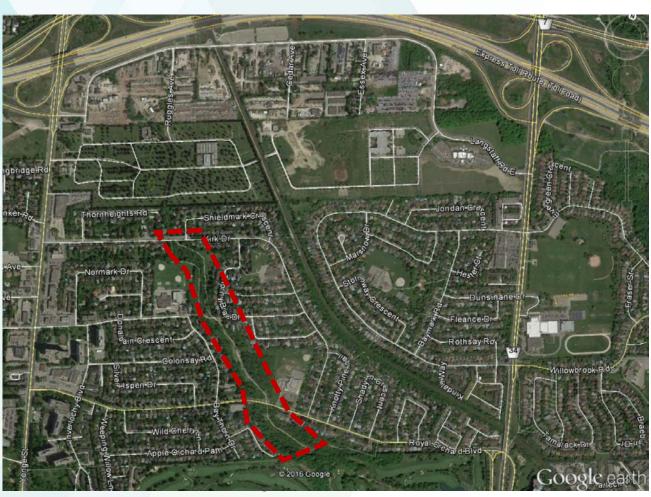
Pomona Mills Creek had numerous steel sheet pile grade control weirs. The weirs present issues with fish passage when functioning, and eventually become outflanked when not functioning.

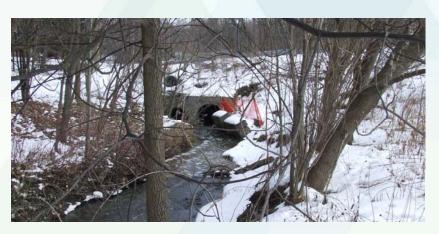
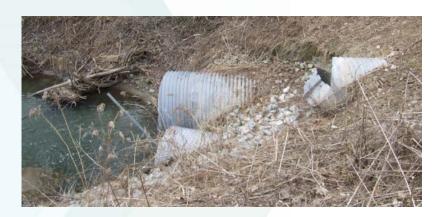
Cobbled together triple culvert (1.8 m, 1.2 m, 0.9 m diameters) crossing of Pomona Mills Creek in Thornhill, owned by City of Markham

Culverts were rusting out, and erosion was present both upstream and downstream of culvert

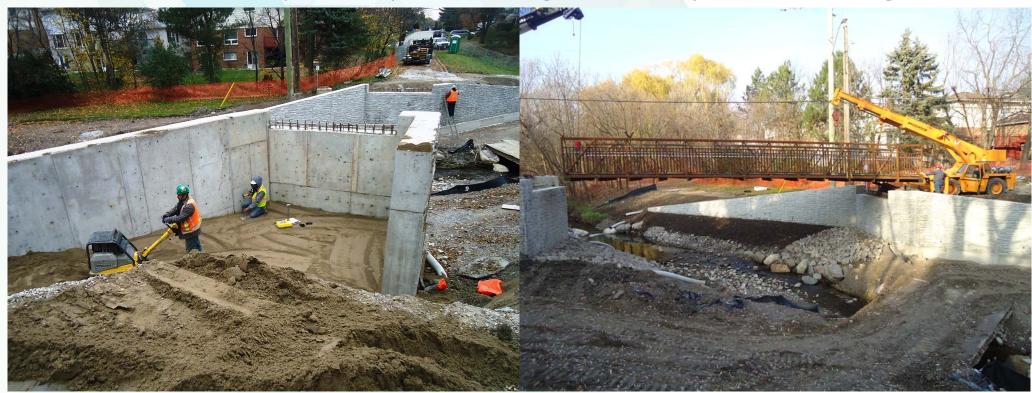
• Culverts were replaced by a 16 m long, 3 m wide pedestrian bridge

- The Creek was opened up through the new bridge as much as possible, reducing erosive forces
- Photo is after July 8, 2013 event

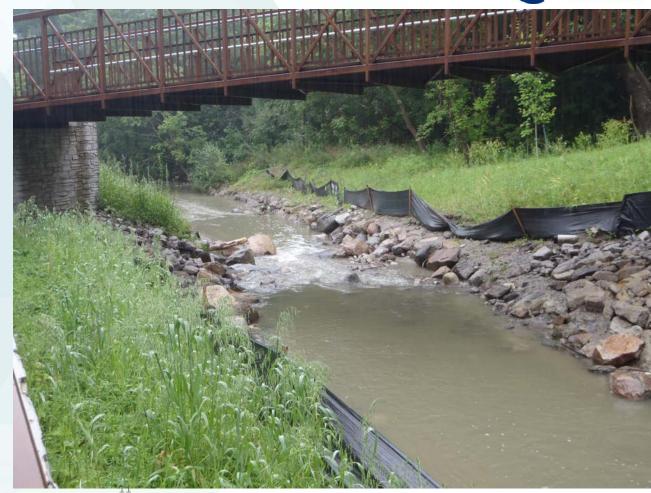
Sheet steel weirs were pulled or cut off at grade and banks cut back to reconnect watercourse with floodplain. Pool/riffle sequences constructed to maintain grade control

- Bridge and removal of 2 weirs completed in early 2013
- A total of 9 more weirs were removed in late 2013 and 2014
- Improved fish passage and vegetation
- Mitigated erosion, protecting path
- After construction of one of the weirs, erosion occurred immediately upstream.
- Lessons learned: Hard grade controls can be avoided when banks are cut back to reconnect to floodplain. Always extend erosion treatment well beyond work area

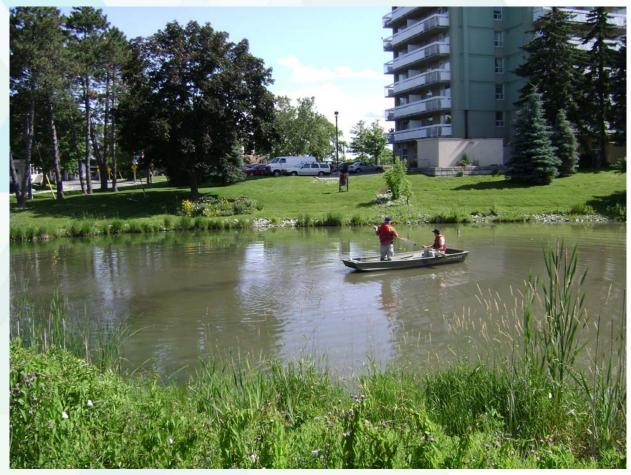
After completion of an alternative assessment, agency coordination and public consultation, Cole Engineering designed a channel to convey sediment laden surface runoff downstream to Fairy Lake to minimize future maintenance needs, including intermittent scour and transport of any sediment within the channel to Fairy Lake.

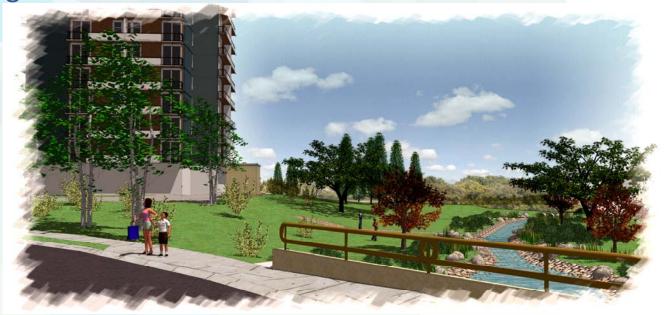
Fairy Lake Garden Pond Design

A Public Information Centre was held at the senior's residence prior to construction. Digital renderings of the design were displayed to allow residents to see how the channel would look. Questions about the design and construction were answered.

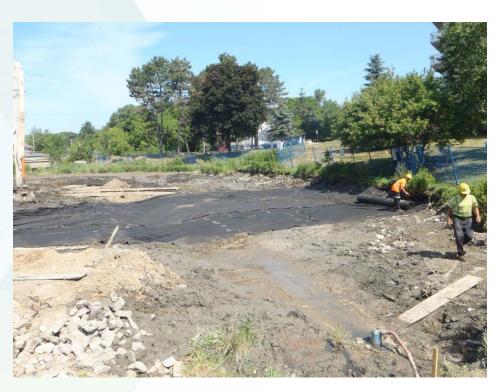
Fairy Lake Garden Pond Construction

- An experienced contractor, R&M Construction, was retained to complete the work.
- Geogrid and granular material was used to cap the sediment to minimize exported material.

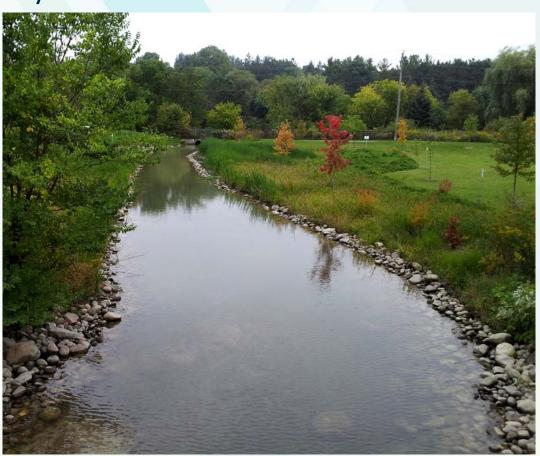
Fairy Lake Garden Pond Construction

- The end result was a channel, including a "nomow" zone that has vegetated well postconstruction.
- Underlying river stone has not displaced, but sediment from upstream areas flows through the site as intended.

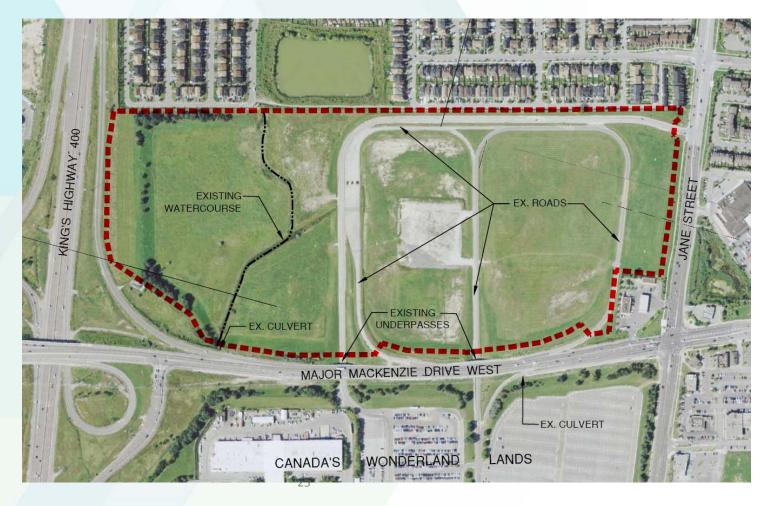
Vaughan Healthcare Precinct Floodplain

Floodplain mapping indicated that the culvert under Major Mackenzie Drive had insufficient capacity to convey regulatory flows, resulting in a large un-natural floodplain and spill to the adjacent underpass.

- Regulation of the floodplain "as is" would have sterilized the site, as insufficient space would be available for the new hospital
- Two new 2.25 m (7.5 ft) diameter culverts were tunneled under Major Mackenzie Drive to lower the flood elevation

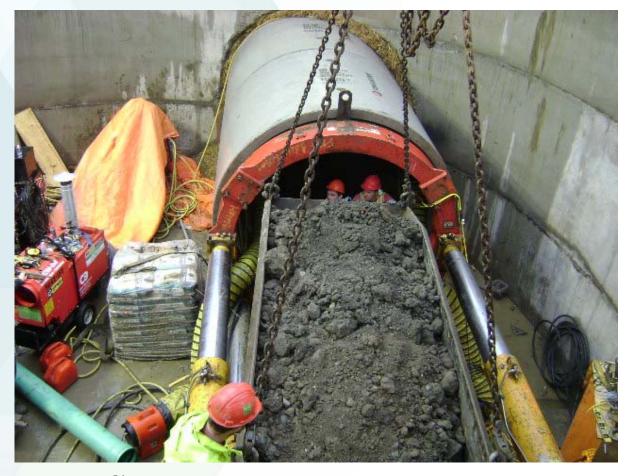
Tunnelling new
2250 mm culverts
under Major
Mackenzie Drive
