Pyramid Slide

Following a landslide in June 2012, a section of Highway 5 between Kamloops and Valemount was threatened with failure as its shoulder slid over 50cm towards the North Thompson River. The Ministry of Transportation commissioned DWB Consulting to stabilize the banks and restore valuable riparian habitat. Repairs to the highway and stream bank occurred in spring of 2013, and although inherently detrimental to the environment, best practices used to restore the "Pyramid Slide" ensured that natural and social values were optimized.

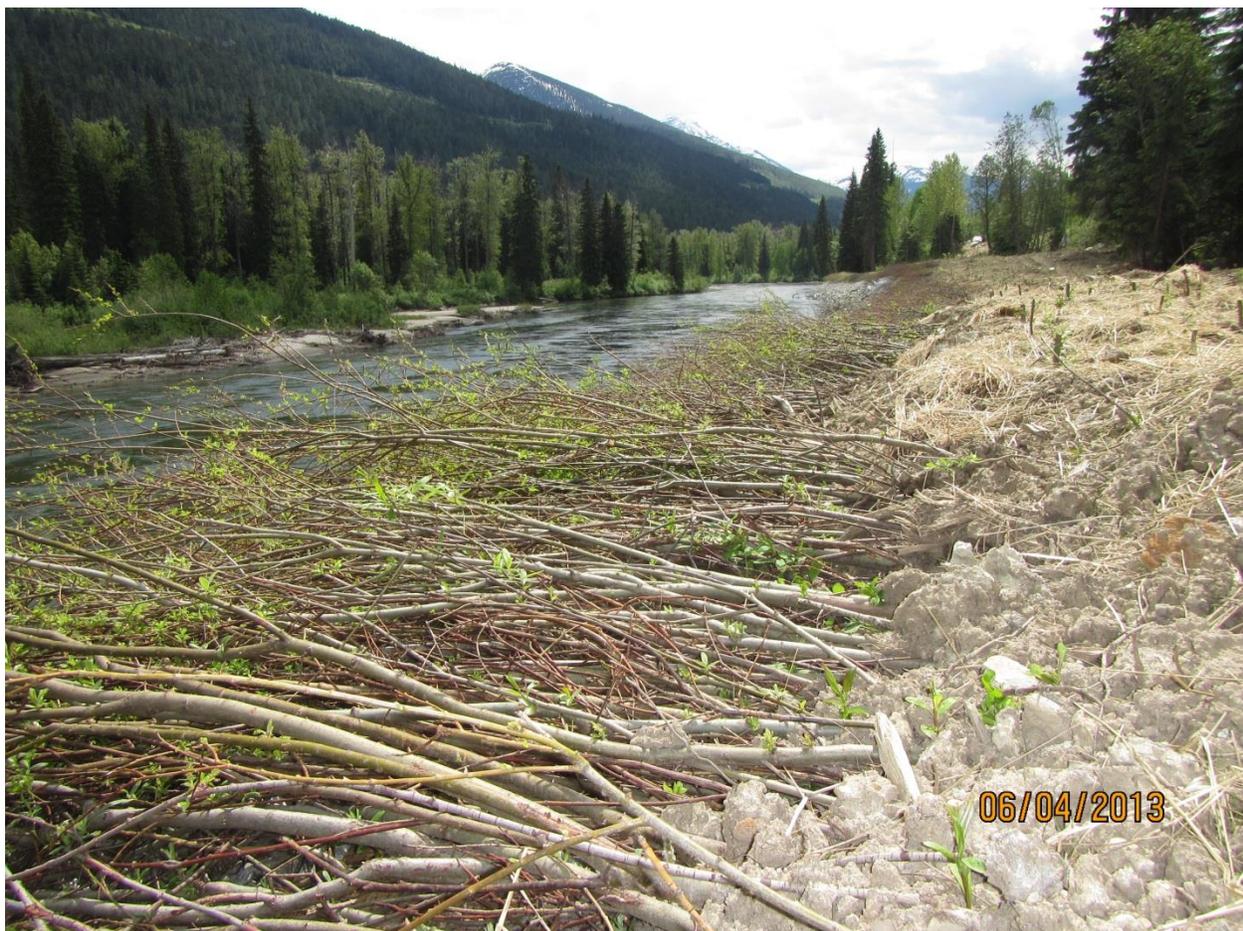
Fish habitat in the North Thompson was created by the addition of angular rock and large wood structures to the main channel. Trees cut during construction were recycled, and cabled to the banks in clumps, creating ten large woody debris clusters. These features provide cover and create hydraulic eddies, benefiting rearing and migrating fish. During construction, sedimentation of the river was controlled with the treatment of straw and poly tarps on exposed slopes, while water bars lined with fabric intercepted runoff water.

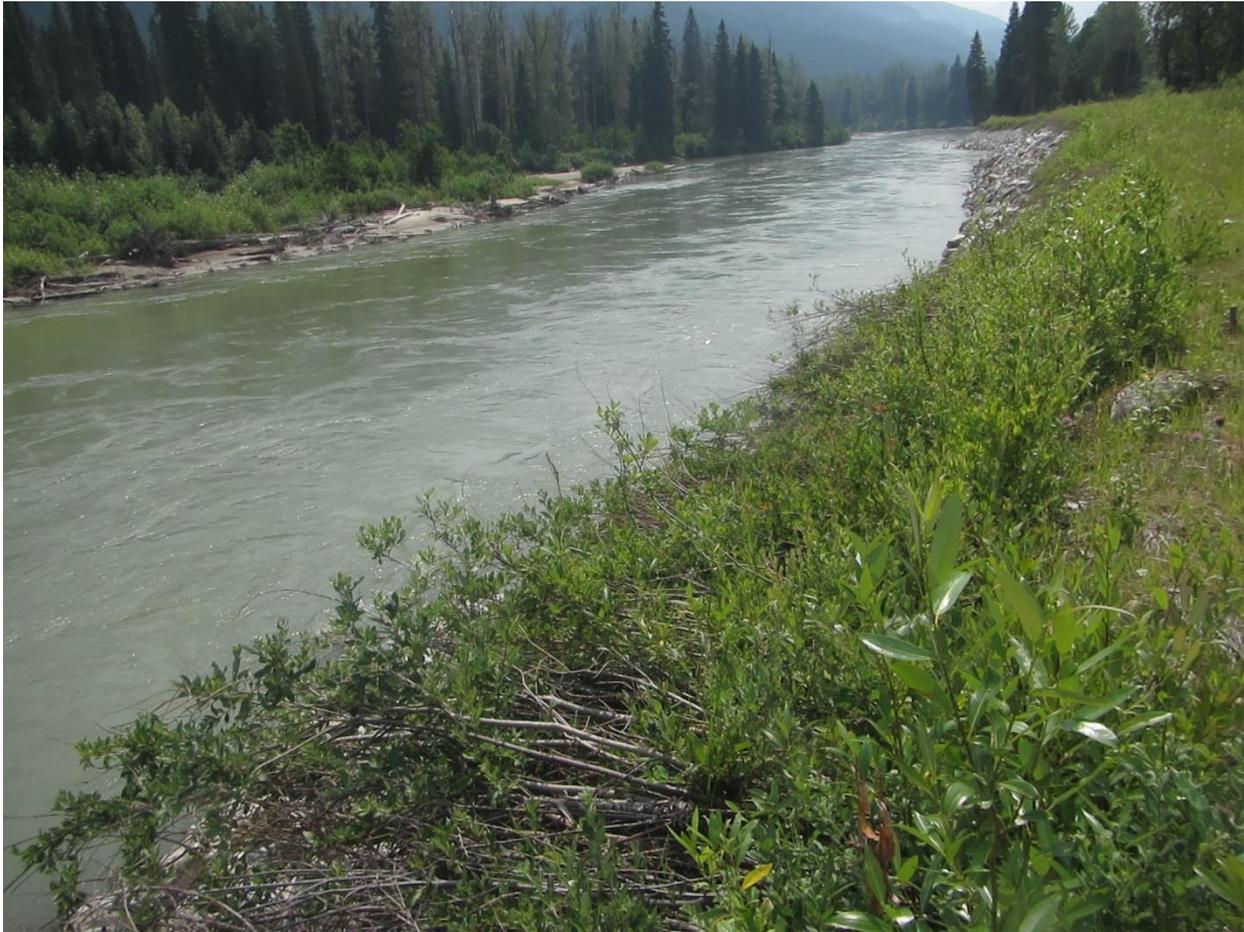
Two years after the incident, the highway is stable, the banks are vegetated, and the site is on the road to recovery.
