Restoring Lost Saltmarsh to Create Habitat Connectivity

*Comox Valley Project Watershed Society
Courtenay, B.C.*

*Article Prepared for the Society for Ecological Restoration – Western Canada Chapter
Prepared by Jennifer Sutherst, Estuary Coordinator & Staff Biologist*

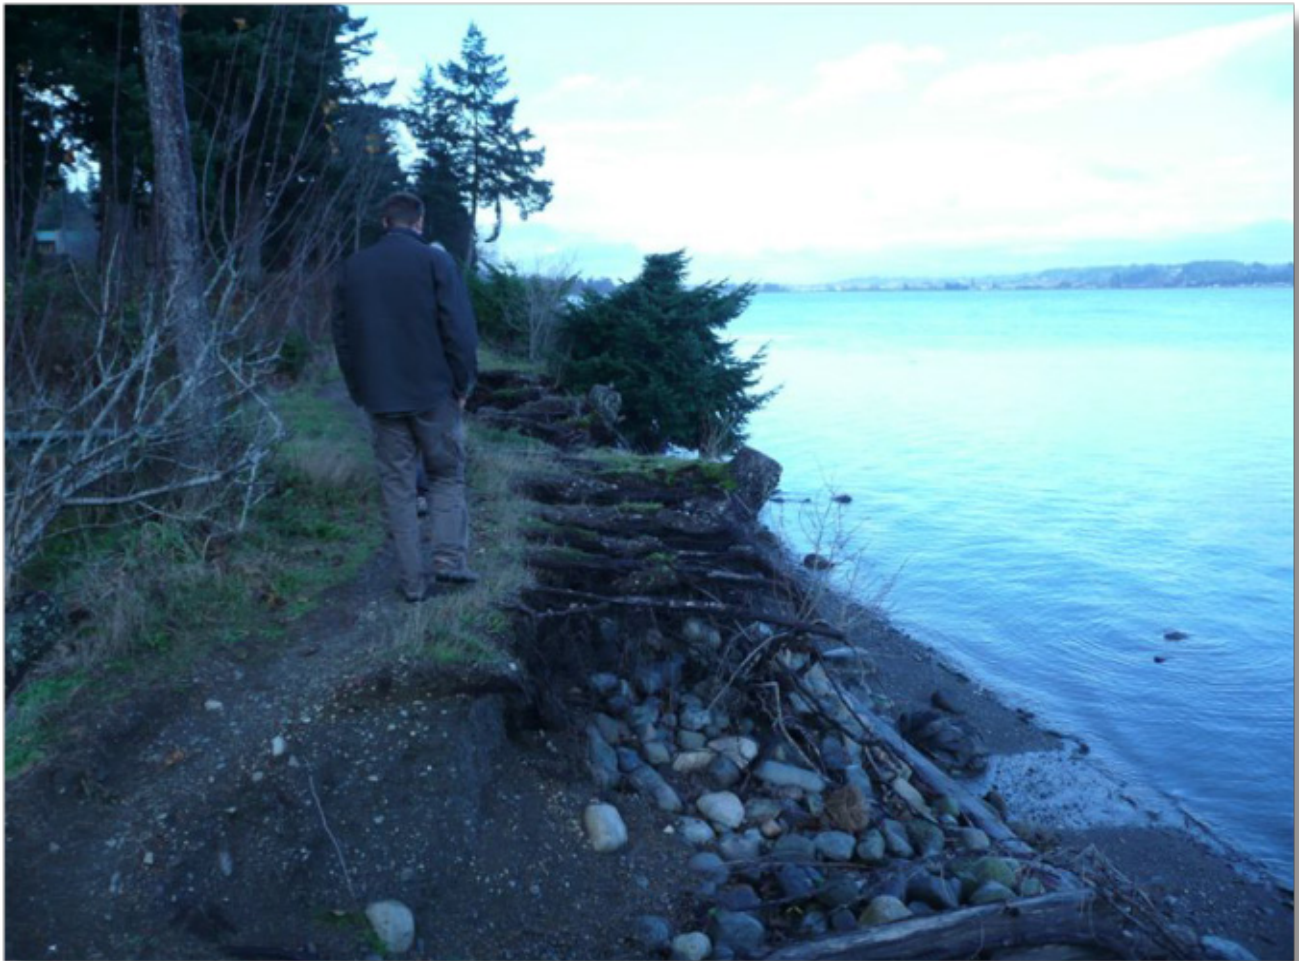
Figure 1: Photo of eroding trail northwest of the site. This portion of the trail has been abandoned due to the erosion.

This was the first time our organization was involved in a saltmarsh restoration and the first time, we believe, that the barrier island technique was used on the west coast of Canada to restore damaged saltmarsh habitat. In other similar projects the most common technique that is used is a saltmarsh bench design, whereby nutrient fill is added to existing foreshore saltmarsh areas and then planted, in order to increase the amount of habitat. The technique we employed was to create three individual linear islands, parallel to the existing saltmarsh, consisting of armoured planting berms with channels in between. By utilizing this methodology we created 360° of edge habitat therefore increasing the amount of habitat overall available to salmonids, and increasing the habitat complexity by allowing for many drainage channels around and in between the islands. This type of design is also useful in protecting the existing foreshore from erosion due to wave action and storm surges. The Comox Valley Regional District was concerned about erosion that was occurring near the Royston Seaside trail, a popular local pedestrian trail, and these barrier islands will help protect against further erosion.

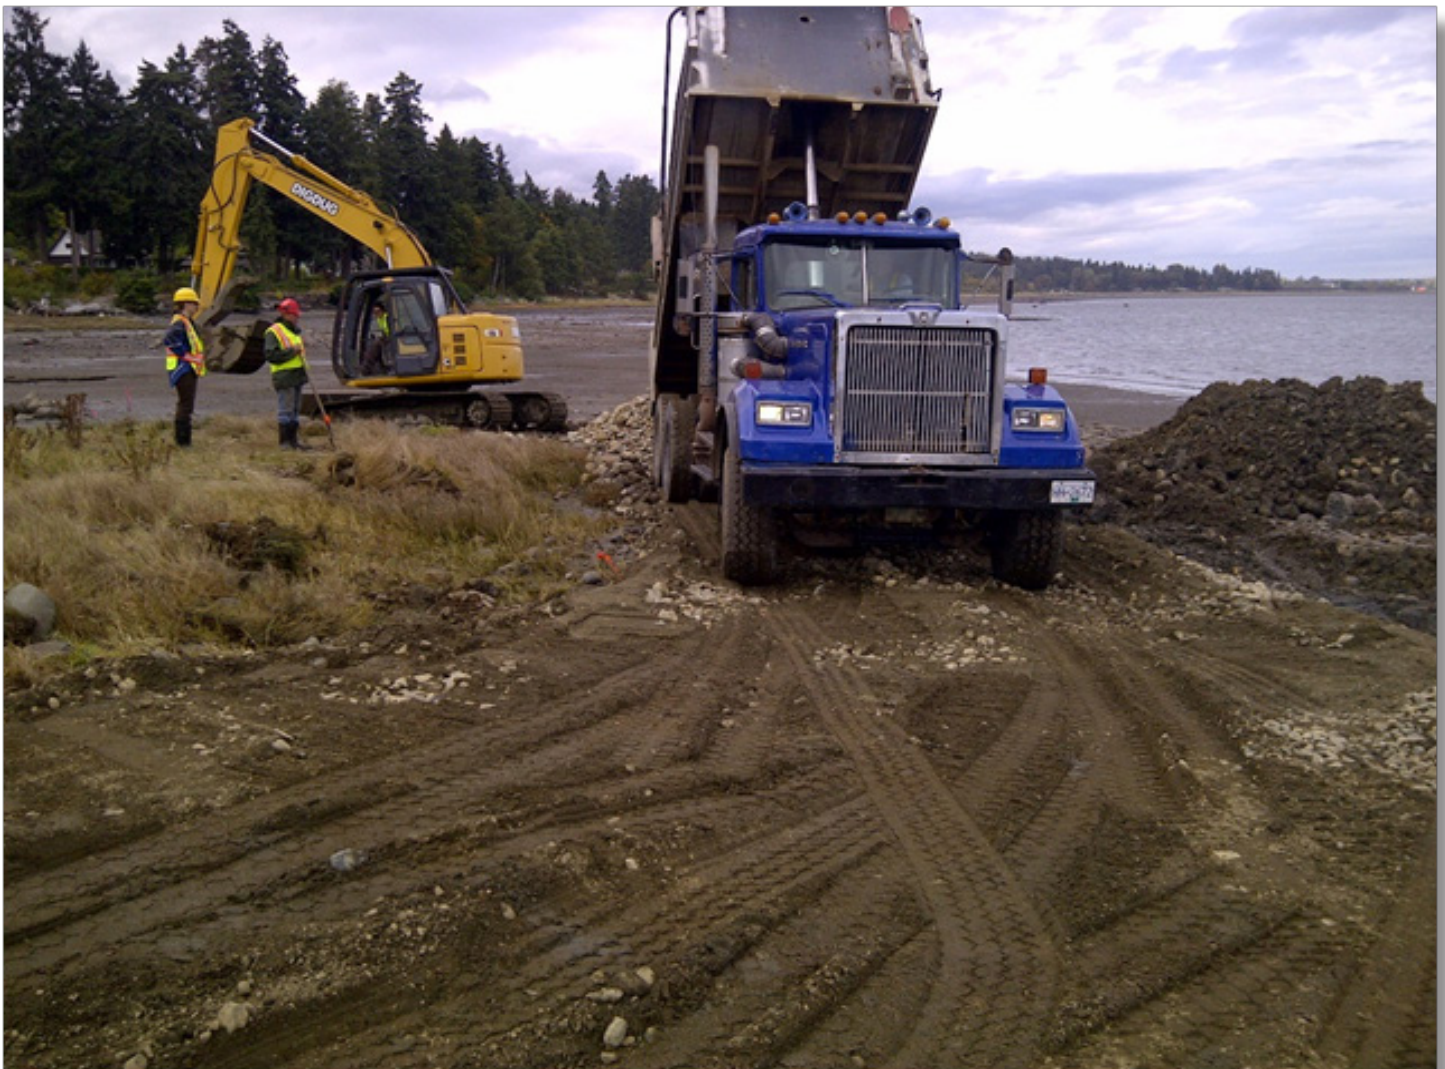
Figure 2: Construction of the berms.

The restoration project featured the construction of 500m² of eulittoral marsh platforms or planting berms. Large equipment was used to add nutrient fill to the foreshore and re-contour it in order to create these berms. The berms had to be constructed at the correct elevation in order to achieve the proper tidal flooding characteristics for the desired vegetation community type to thrive. In this case a vegetation survey, conducted at the site the year before, determined that we had lower marsh communities dominated by *Salicornia depressa* and upper/middle marsh species that included *Distichilis spicata*, *Carex lyngbyei* and *Grindela integrifolia*. The elevation criteria we used were obtained by referencing the nearby saltmarsh habitat which was located in a similar geomorphic landscape setting. Based on these surveys, and the vegetative community we wanted to establish, it was determined that the planting berms had to be built at a 4% slope between 0.8 and 1.2 m high. The vegetation scheme and planting plant were designed by Tanis Gower of Fernhill Consulting.

These planting berms also had to be armoured with large natural boulders in order to protect them from the prevailing wind and wave action as well as from tide and storm surges. As part of the preliminary planning for this project a detailed hydrological survey of the area was conducted by Northwest Hydraulic Consultants in order to understand the wave forces, tidal influences and patterns of sediment recruitment and erosion at the site. A hydrological engineer reviewed the saltmarsh concept plans and provided the details of the design.

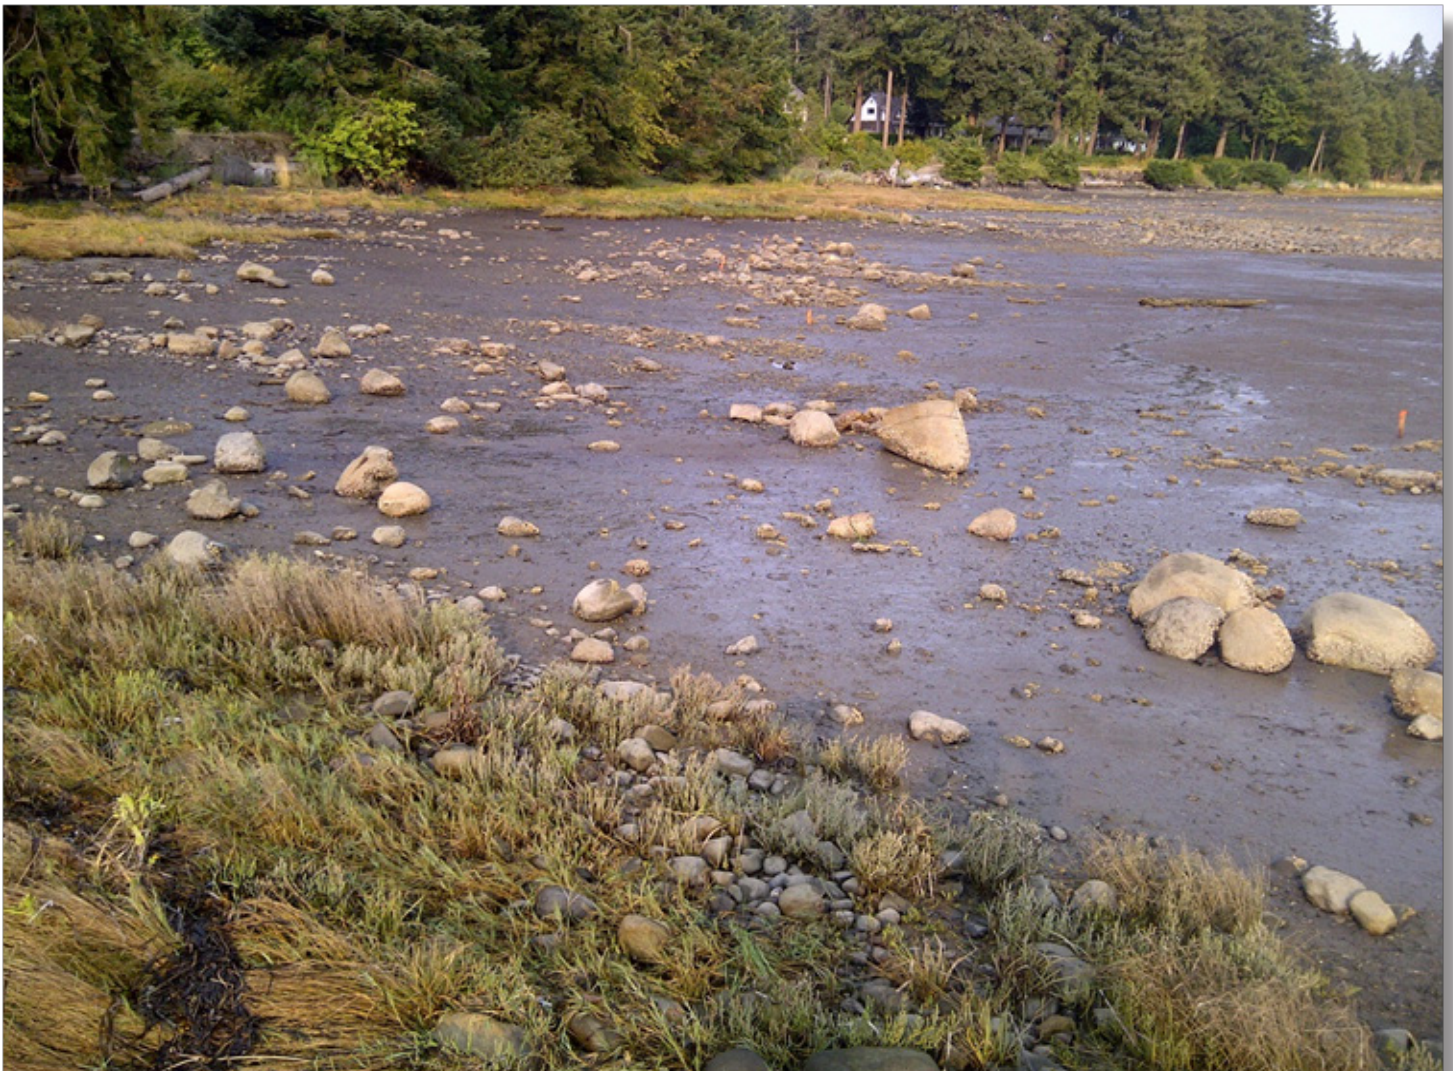
Figure 3: Area before the saltmarsh islands.

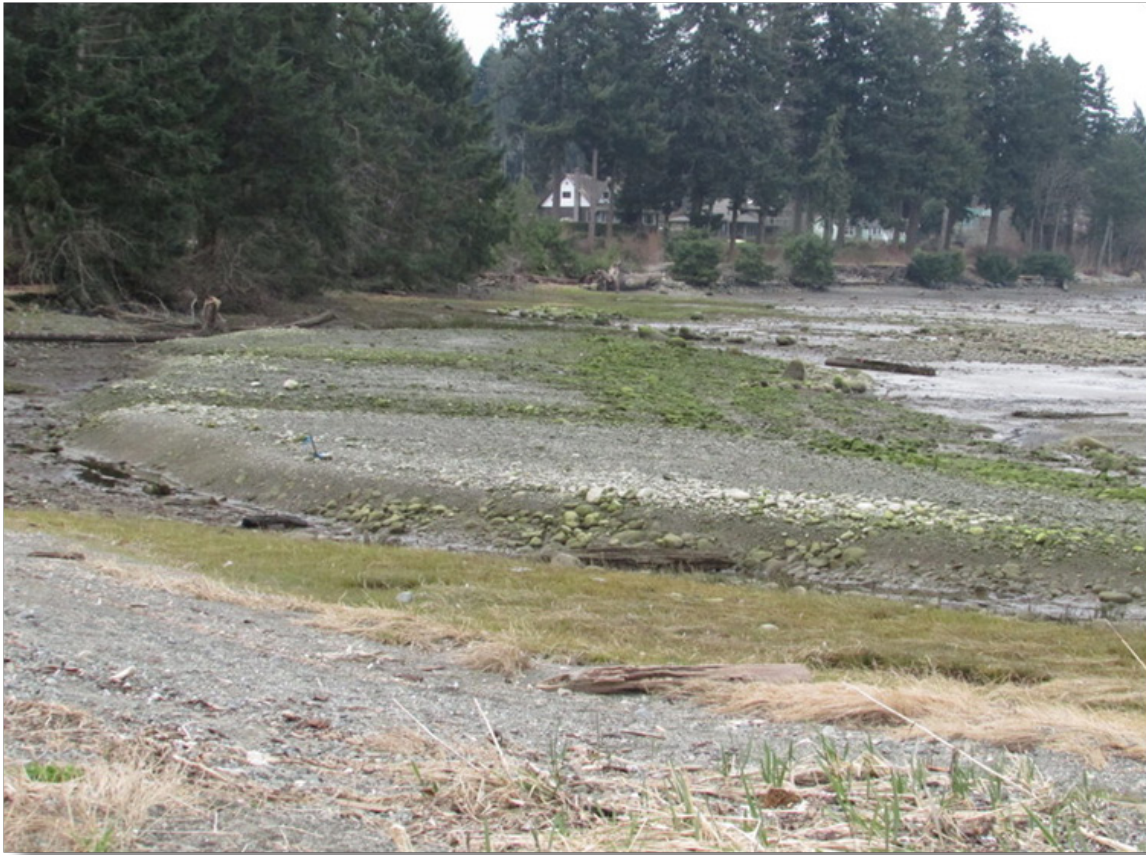
Figure 4: Same area after the saltmarsh islands were completed.

The breakwater, that was put in place to protect the log booms, has disrupted the normal pattern of sediment delivery along the shoreline, starving the site of sediment and causing the erosion of existing saltmarsh. The newly constructed berms were stabilized along their lower margins with boulders, of specific size, placed at a 1:10 slope. This ensured the nutrient fill we used to enrich the beach would be retained on site. As well, the way in which the islands have been constructed should ensure long-term recruitment of sediment through natural processes.

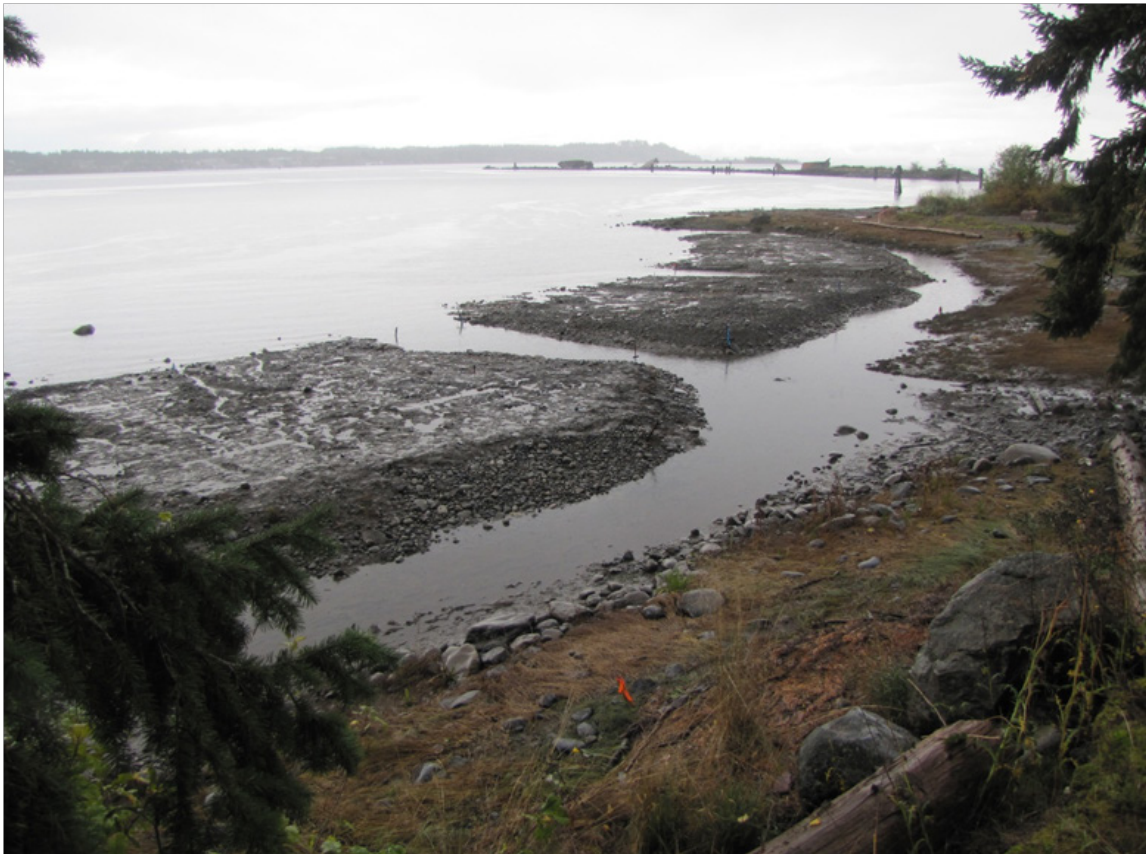
Figure 5: Newly built islands showing tidal drainage channels.

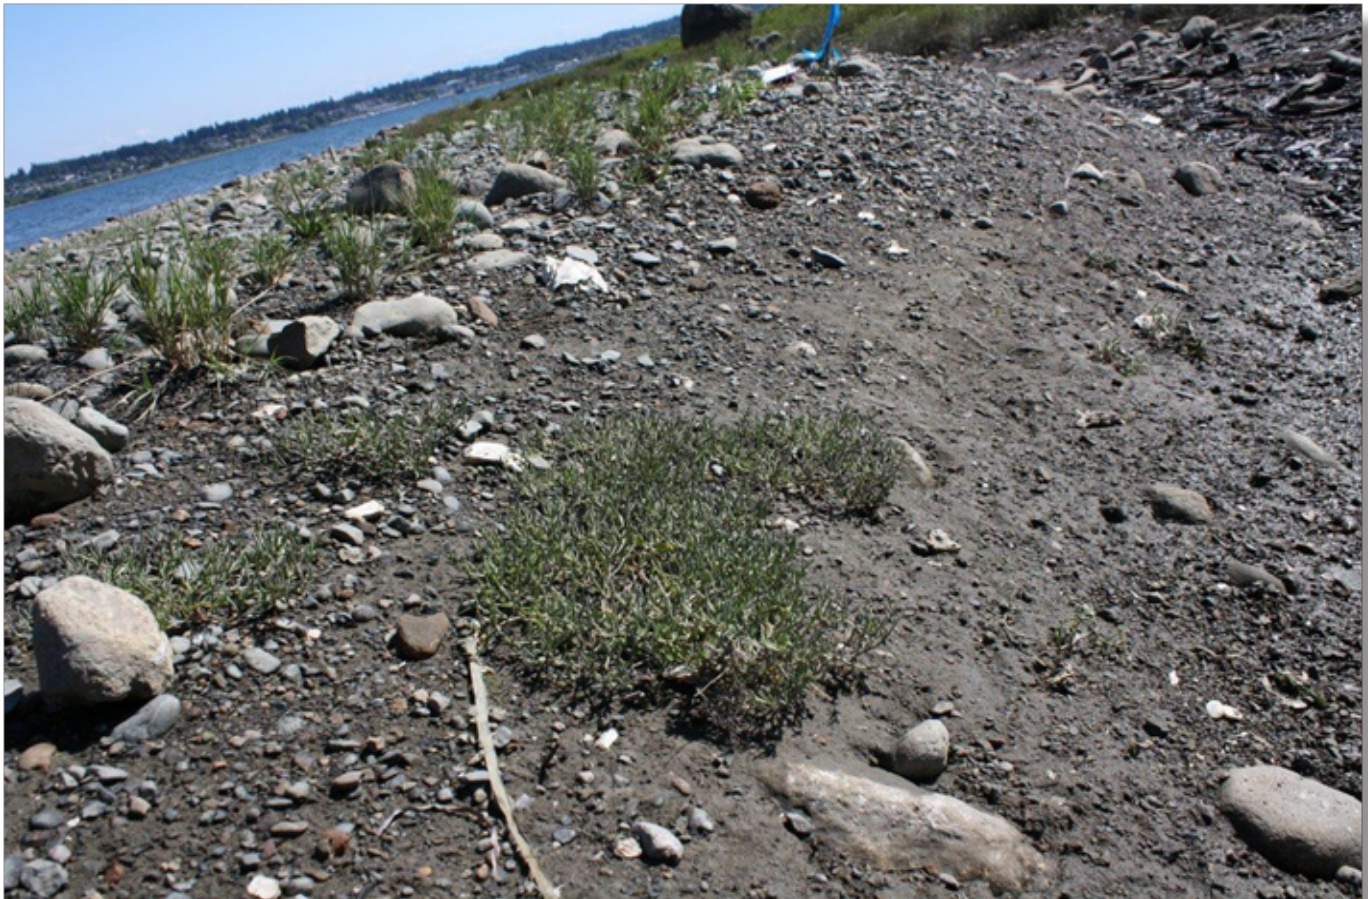
Figure 6: Shoulder areas showing natural recruitment of pioneer plants.

The islands were allowed to overwinter. They successfully withstood the first winter storm season and were planted with over 6,000 saltmarsh plants in the spring. A mix of native species was planted, with an emphasis on those that have stabilizing root systems and can create dense cover. Some of these species include *Distichilis spicata*, *Triglochin maritimum*, *Salicornia depressa*, and *Carex lyngbyei*. The first spring after the islands were constructed pioneer plants, including *Atriplex patula* and *Spergularia Canadensis*, started to recolonize the islands. Much of this natural recruitment was observed on the shoulder areas of the saltmarsh islands; which were not planted as part of the project.
