Gas plant site to be restored, March
11, 2010

This is the site of a former gas processing plant just south of Edmonton AB. Contaminated soils have been cleaned up and the site is now ready for restoration. Traditionally sites such as this would be seeded with an agronomic mix of grasses and legumes and the site would remain with this cover, often augmented by weeds as the agronomic grass cover is an unhealthy ecosystem. This weakness is exploited by weeds. In this case, however, we chose to move along the natural successional trajectory directly into a woody pioneering stage of succession.

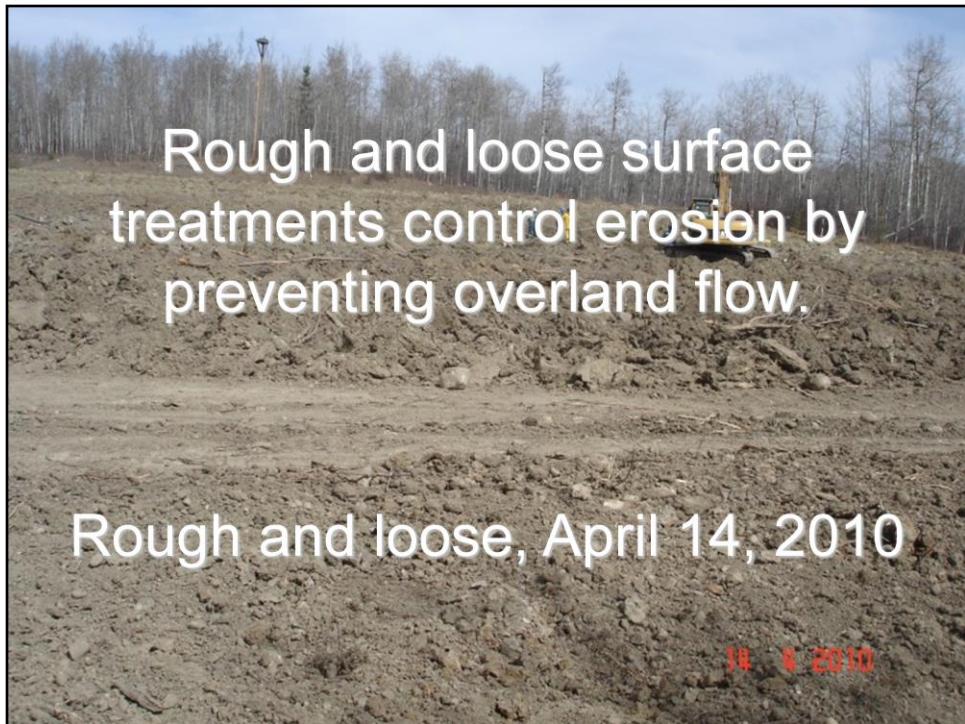
Erosion is often cited as the reason for using a grass and legume seeding. However, making the ground rough and loose prevents water from running across the surface of the land and encourages infiltration, moving water into the groundwater system. Rough and loose treatments were used on this site. Rough and loose surface configurations can be achieved by using a large excavator to open holes on the slope, dumping the material that is generated from the holes in mounds between the holes. The excavator, using a digging bucket (not clean-up), takes a large bucket full of soil and places it to the left of the hole that was just opened, half a bucket width from the hole so it is half in and half out of the hole. A second hole is then excavated half a bucket width to the right of the first hole. Material from this hole is then placed between the first and second holes. A third hole is now opened half a bucket width to the right of the second hole, with the excavated soil placed between the second and third holes. Care should be taken when excavating the holes to shatter the material between the holes as the hole is dug. The process of making holes and dumping soil is continued until the reasonable operating swing of the excavator is reached. The excavator then backs up the width of a hole and repeats this process, being sure to line up the holes in the new row with the space between the holes (mounds) on the previous row.

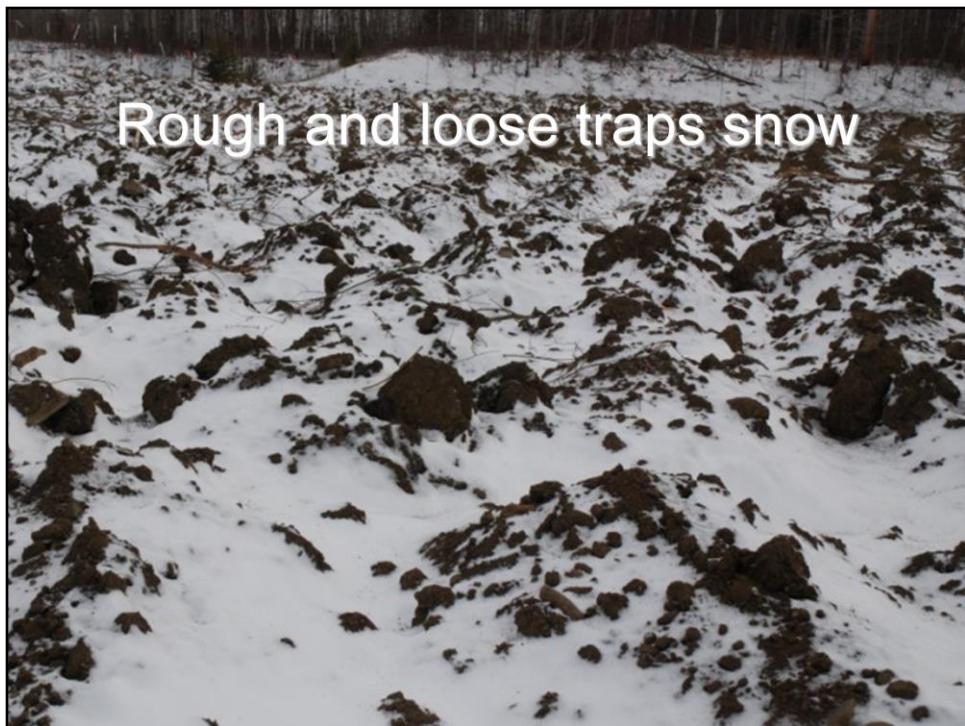
In addition to preventing erosion, the rough and loose treatment traps snow, adding to the soil moisture that will help plants grow in the spring.

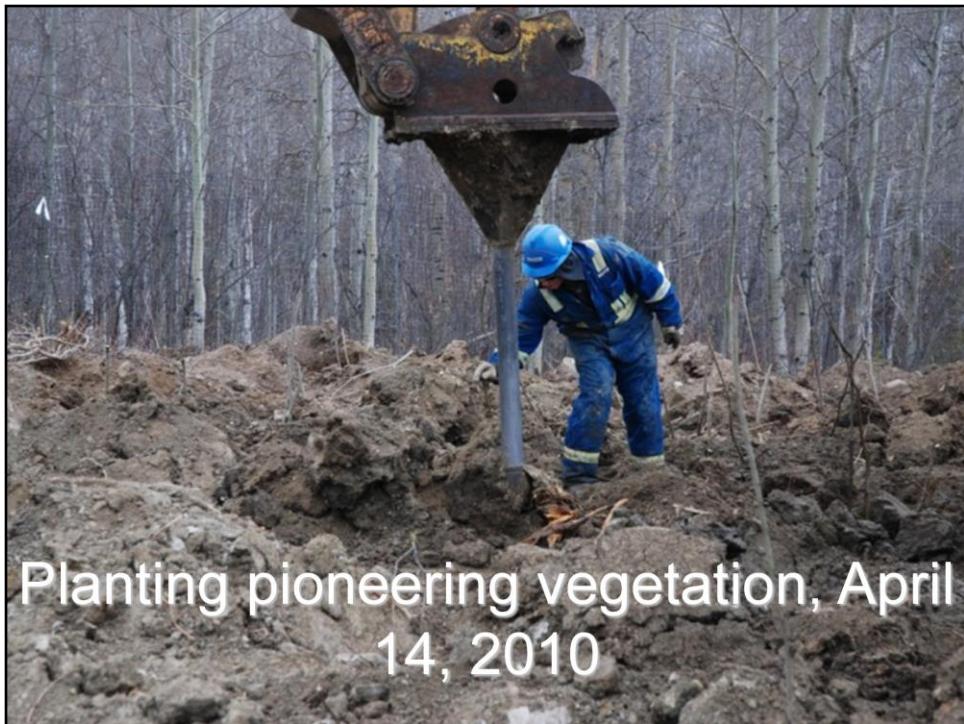
Planting pioneering vegetation, April 14, 2010

Pioneering woody species were established from 2 m long dormant stem cuttings with 1 m in the ground and 1 m above the ground. A large poker was fitted to an excavator to open holes for the cuttings. Willows, balsam poplar and red-osier dogwood were used.

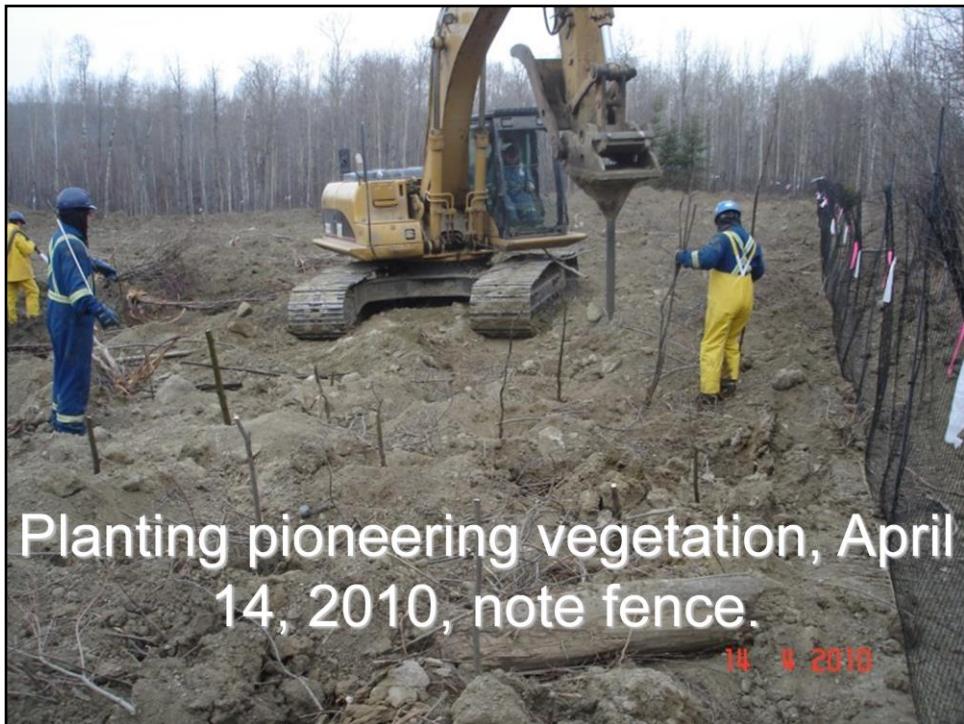
Planting pioneering vegetation, April
14, 2010, note fence.

Cuttings were planted at about 1 m spacing to provide a dense cover early in the recovery processes. Note the fence which was established to keep deer and moose from eating the new sprouts on the cuttings.

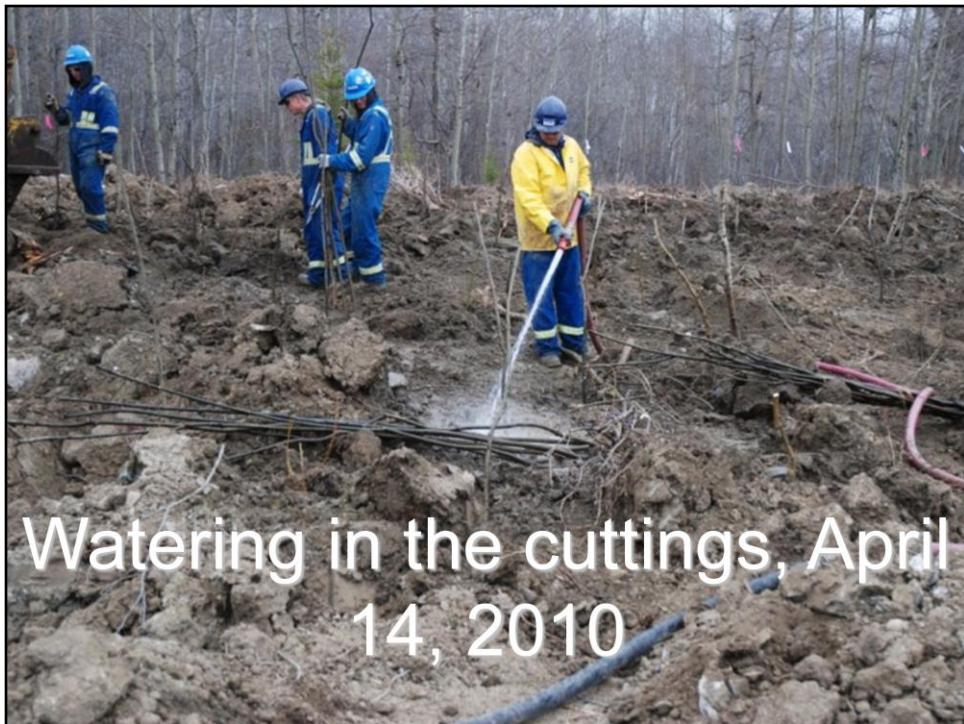
Watering in the cuttings, April 14, 2010

A high pressure hose was used to wash the soil into the hole around the cutting so that there were no air pockets and the cuttings had good contact with moist soil. This also provided water so that the cuttings would not dry out during the first few weeks after planting.

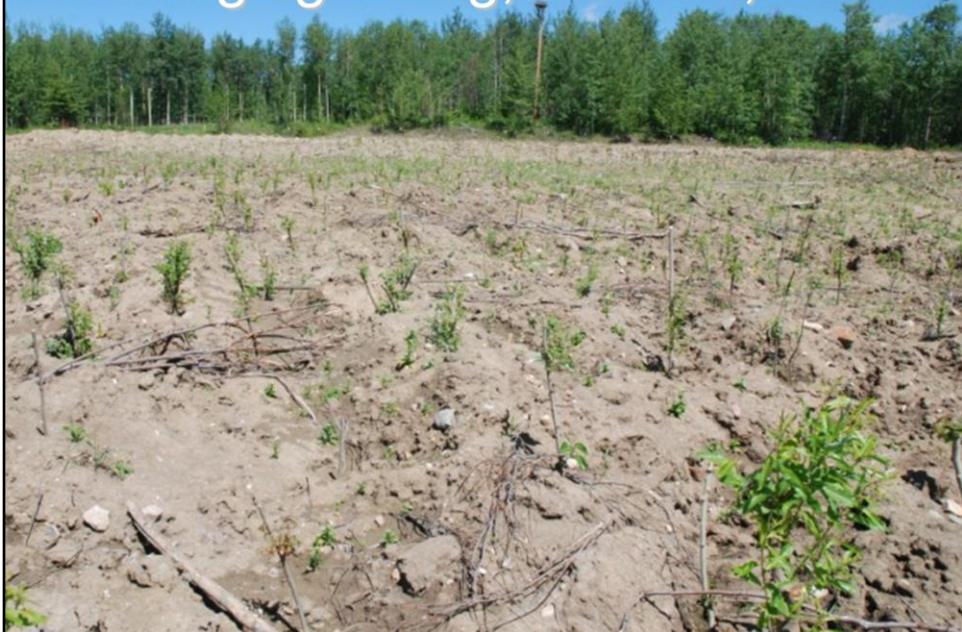
Cuttings growing, June 24, 2010

Growth of almost all of the cuttings had started by June 24th.

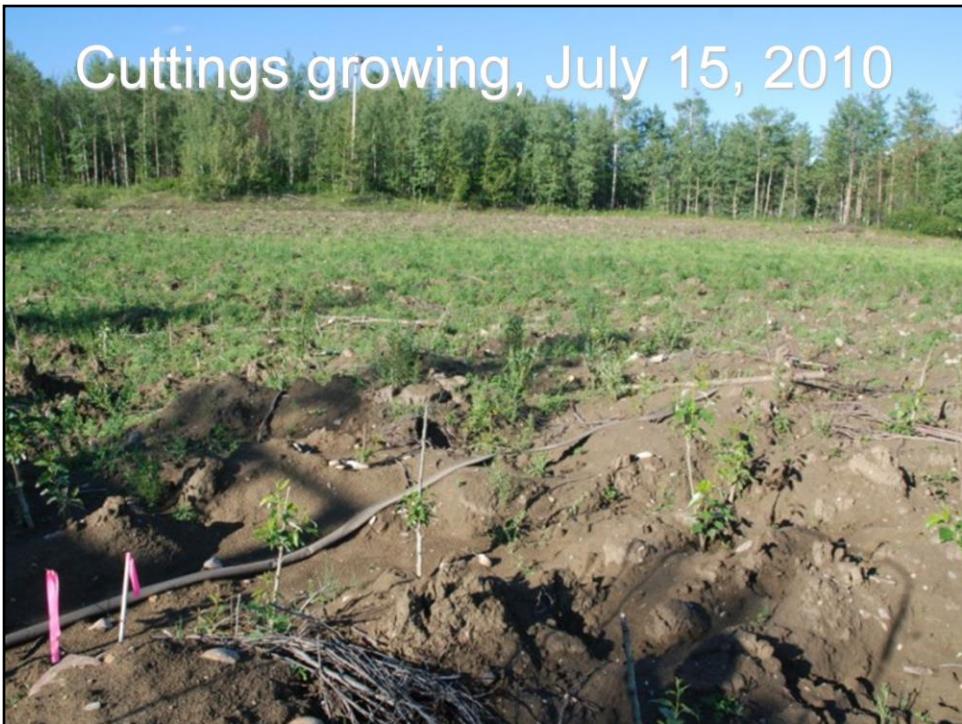
Cuttings growing, July 15, 2010

As the summer progressed, in addition to the cuttings, seeds of a wide variety of plants that had been in the soil seed bank started to sprout and grow.

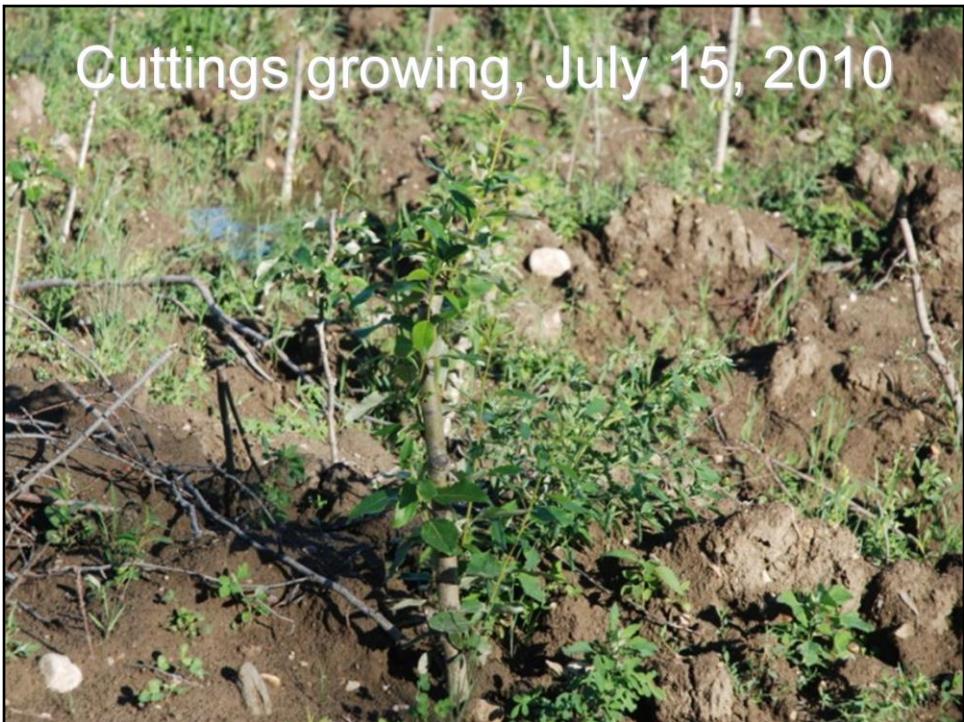
Cuttings growing, July 15, 2010

Active growth of the cuttings benefits from the moisture trapped by the rough and loose ground.

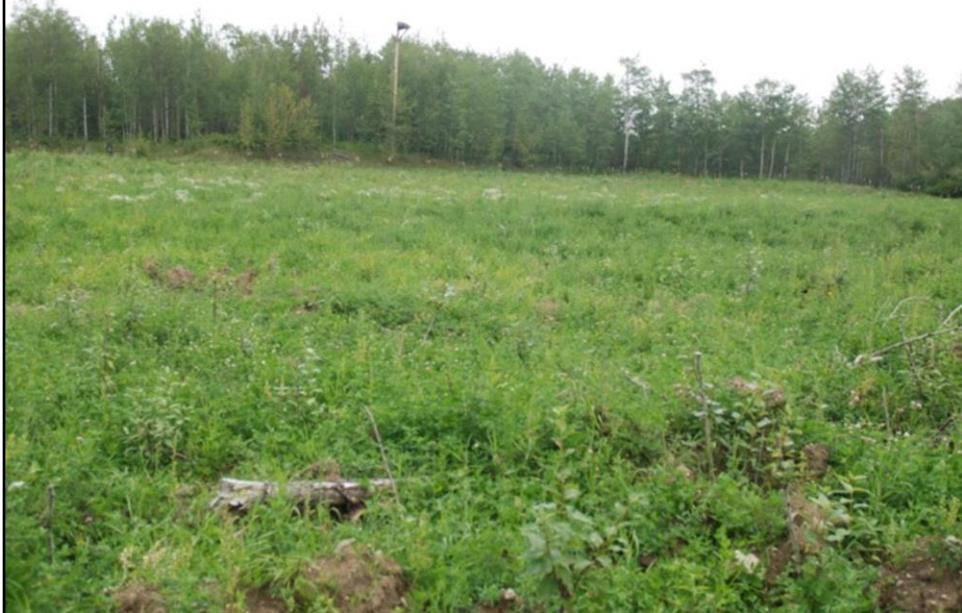
August 17, 2010

By August the site was covered with the various species from the soil seed bank as well as the woody trees and shrubs growing from the cuttings.

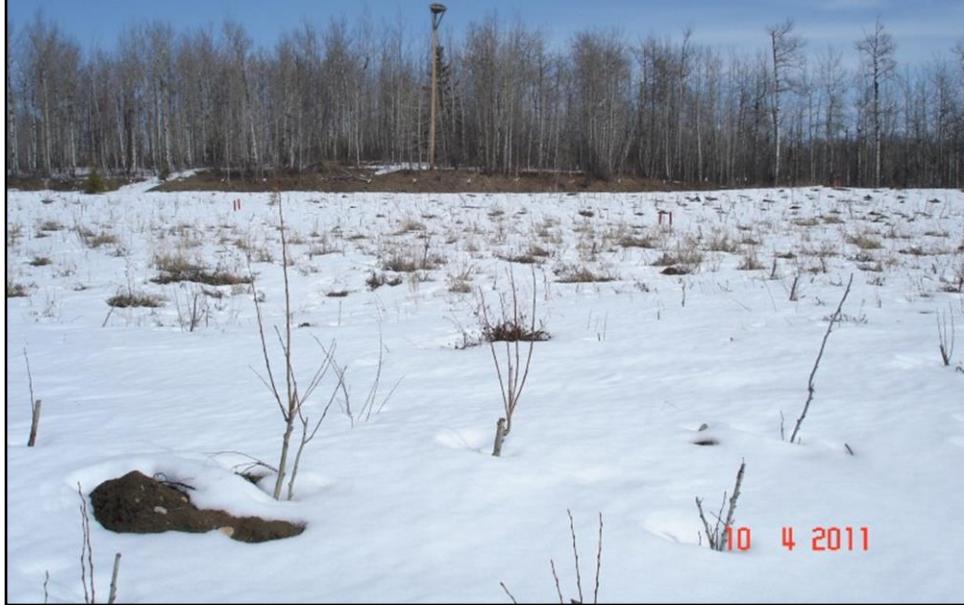
April 10, 2011

A winter inspection illustrates the differential melting of the snow so the mounds melt first with the hollows remaining snow covered longer.

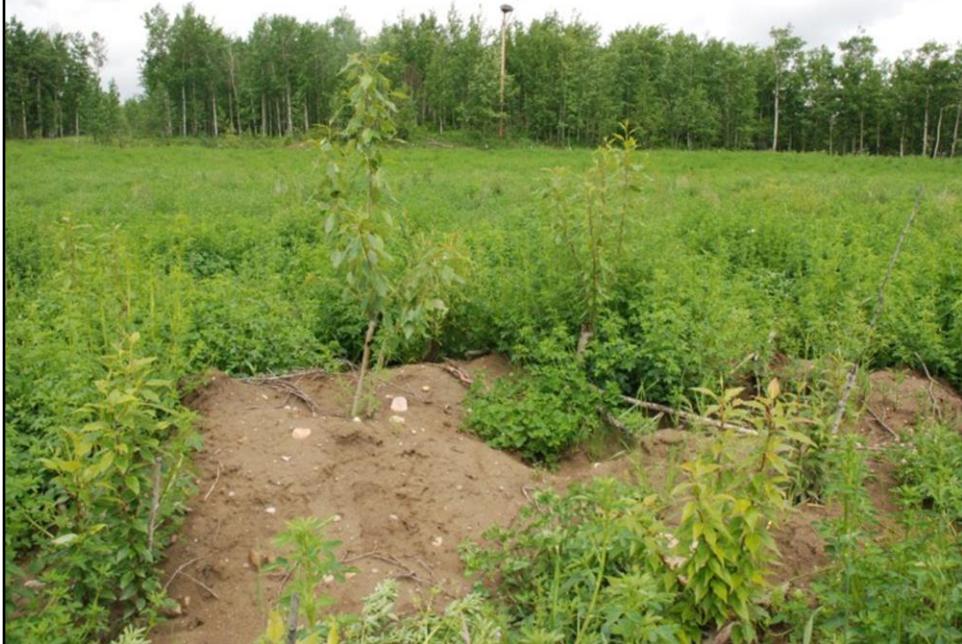
June 20, 2011

The second growing season shows the rough and loose texture moderated by weathering as well as the continued growth of the woody species.

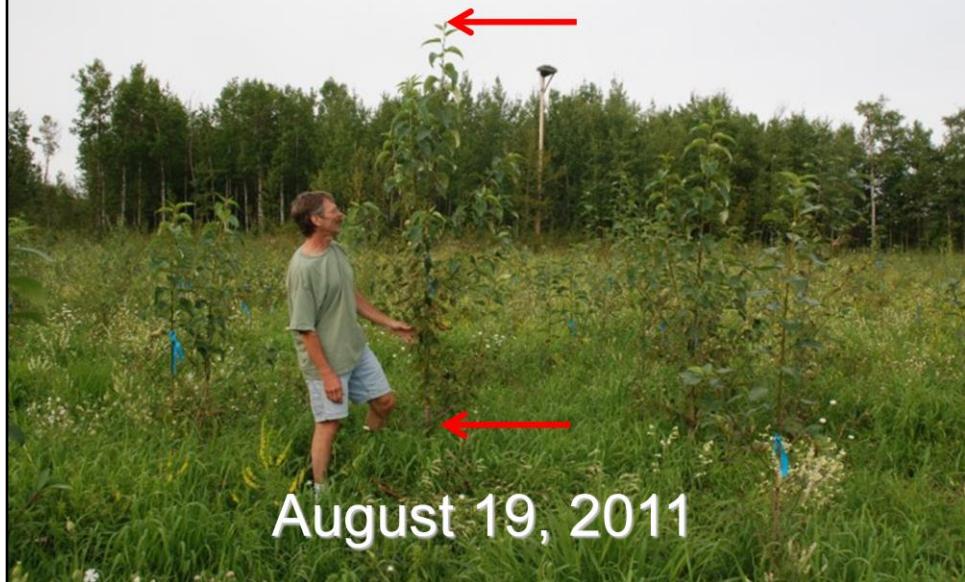
Two growing seasons...

The arrows show two growing seasons of growth at this site just south of Edmonton, AB.

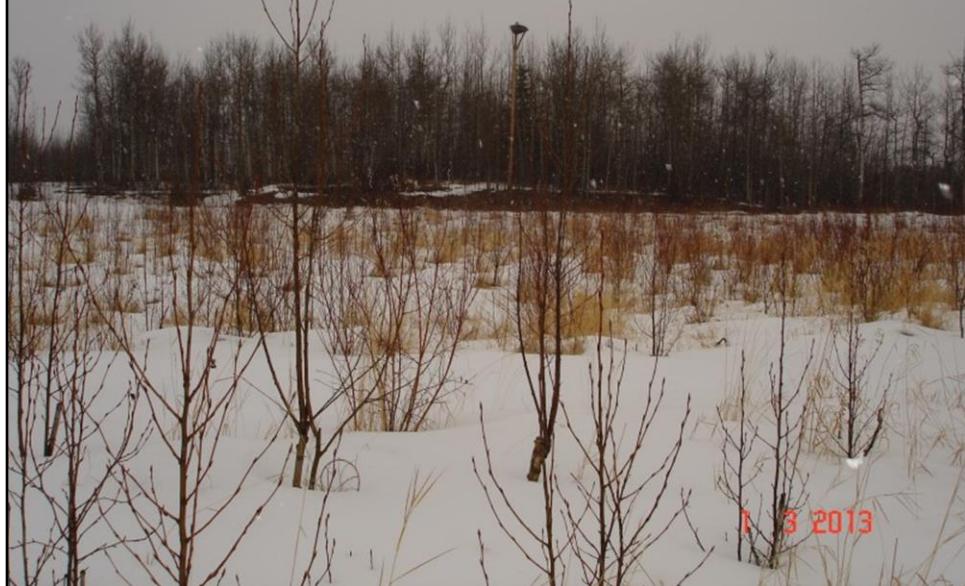
March 1, 2013

Woody species now dominate the site with some of the Balsam Poplar over 3 m high.
