Faux Beaver Dam Installation and Evaluation in the Potlatch Watershed

During the summer of 2016, Latah Soil and Water Conservation District (LSWCD), Alta Science and Engineering, and other partners installed structures intended to mimic natural beaver dams (Faux Beaver Dams or FBDs) on two creeks on private properties in the Potlatch Watershed: Corral Creek and Big Bear Creek. The circumstances on these two creeks are different, so design, installation procedures, and outcomes also differ.

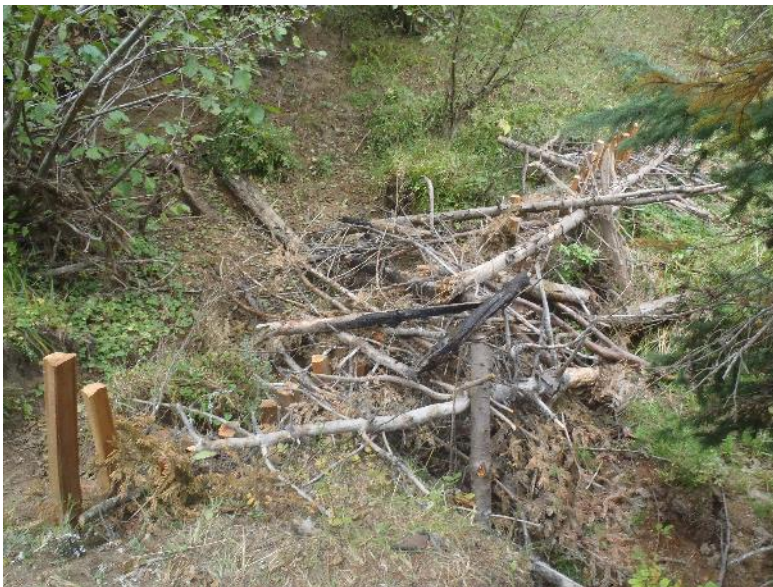
Figure 1. Corral Creek FBD After Installation

installed slightly staggered 4-inch cedar posts in the streambed using a hydraulic post pounder. Next they tamped a “wedge” of rock and mud along the upstream side of the post row. Slash and branches harvested from nearby pine, fir, and spruce trees were woven through the post row. In some cases, they placed rows of sticks on top of the slash parallel to flow and angled along both sides of the structure to help prevent scour around the posts (Figure 1).

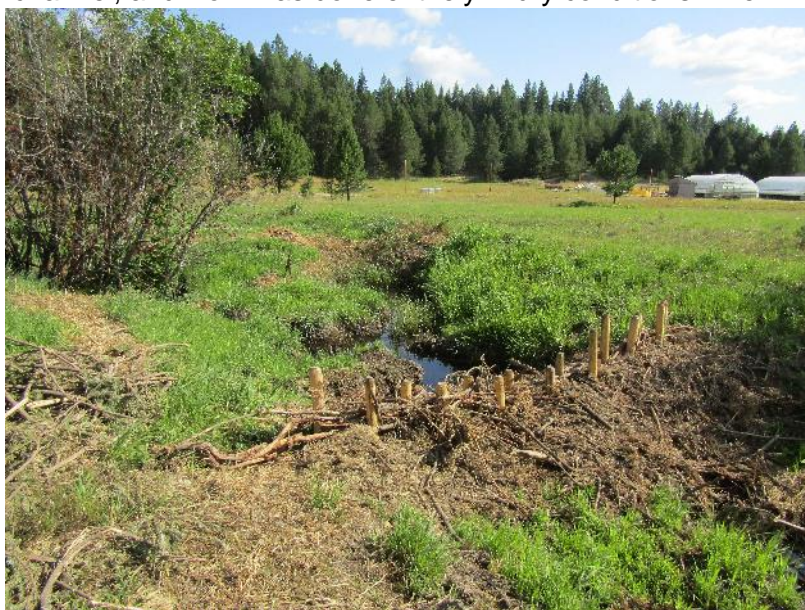
to drive 6-inch untreated wood stakes into the streambed and place slash, brush, and woody debris on and around the posts. A newly constructed FBD is shown in Figure 2.

Figure 2. New FBD in Big Bear Creek.

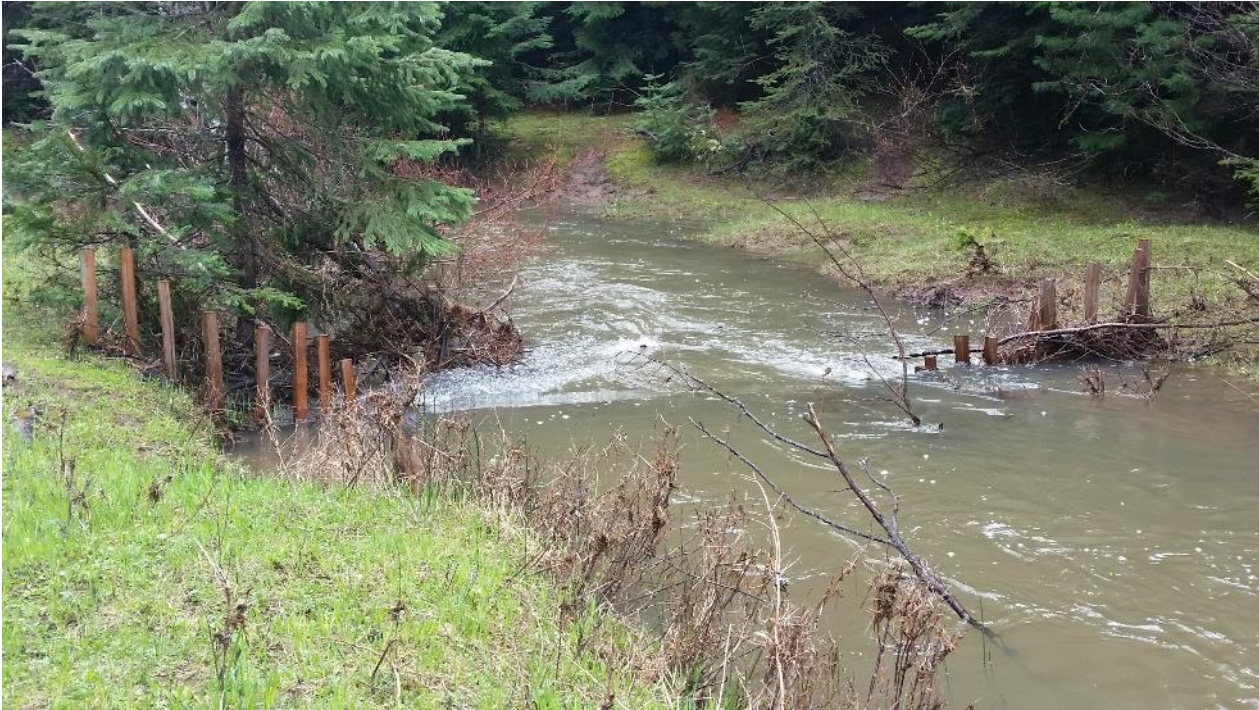
At both sites the FBDs were largely submerged at high flow. As the flow started to recede, evidence of backwatering behind the structures was noted in some, but not all cases (Figure 3). In all cases fish passage routes were observed around or over FBDs. The structures were providing backwater and upstream flooding. The aerial photo in Figure 4 shows a FBD on Big Bear Creek during high flow. It is mostly submerged, and contributing to extensive meadow flooding.

Figure 3. FBD on Corral Creek during receding flood flow.

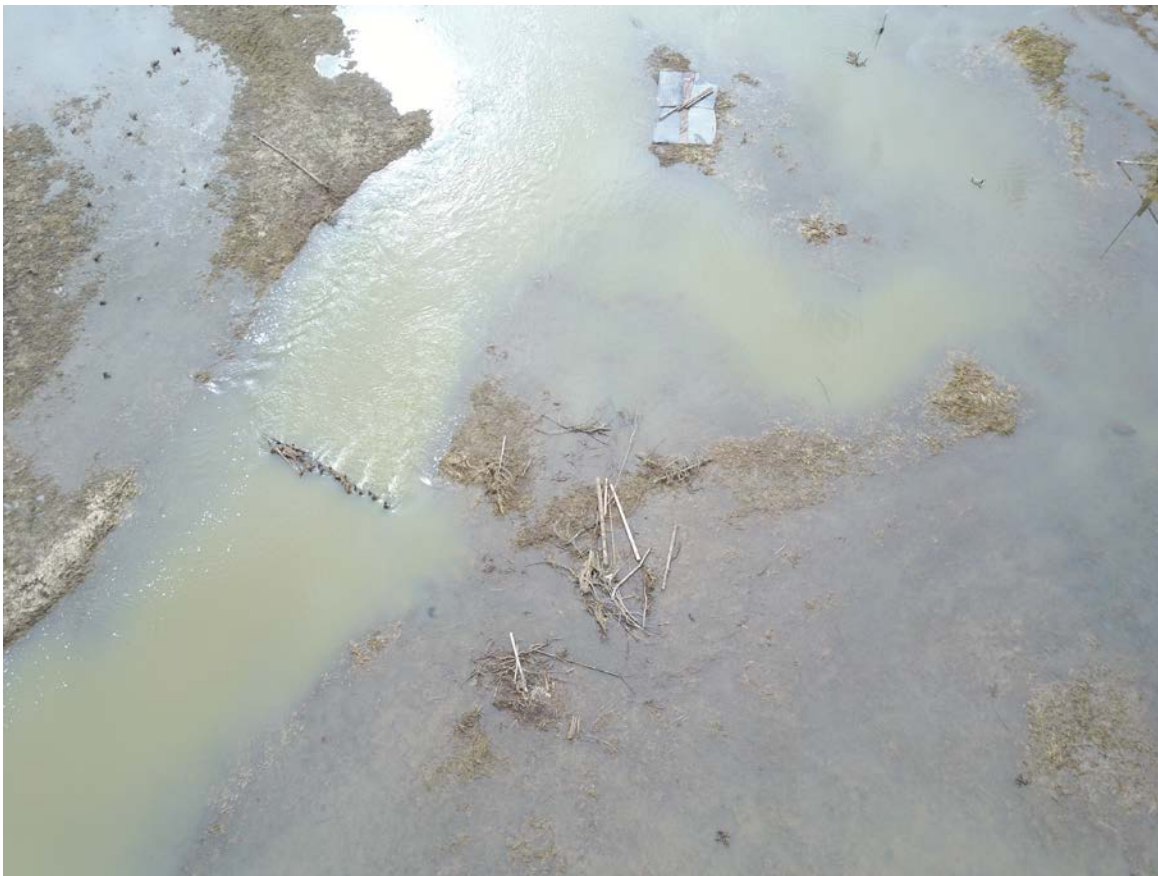
Figure 4. Aerial image of FBD on Big Bear Creek at high flow.

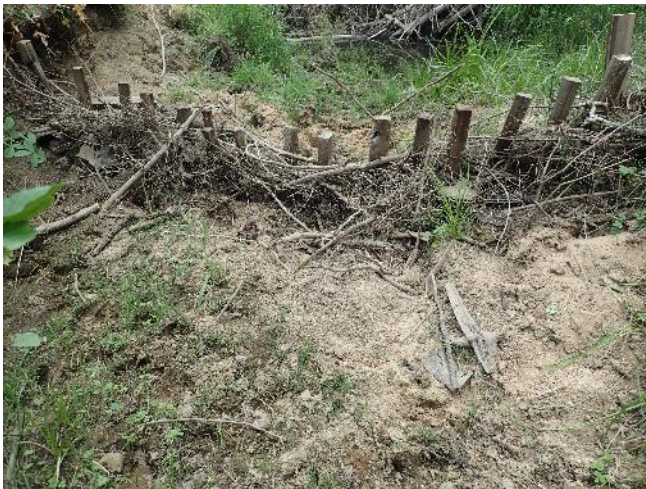
New sedimentation was noted at most structures, including the damaged FBD, and new beaver activity was discovered at two locations. In several cases, pools upstream of FBDs were holding water well into August. All the FBDs on Big Bear Creek had accumulated wood and sediment, and some were retaining water late in the summer.

Figure 4. Sediment accumulation at FBD

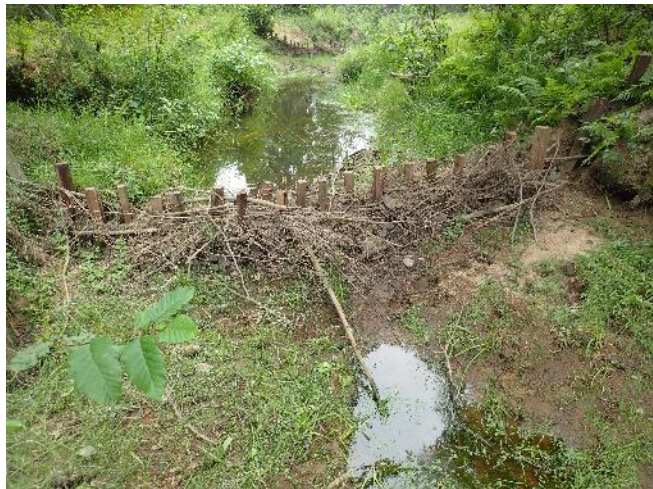
Figure 5. Pool created behind FBD

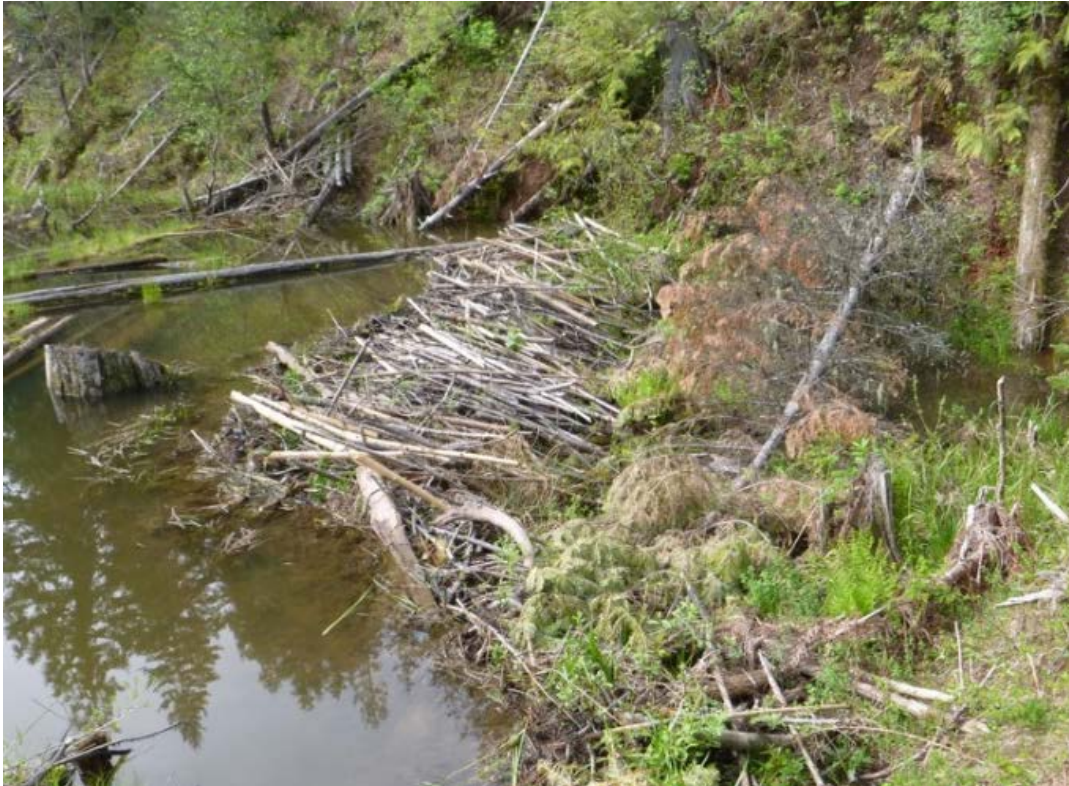
3. Always install angled sticks along the downstream side of the BFD to prevent scour. Beavers do in this area as shown in Figure 6.

Figure 6. Real Beaver Dam with Scour Protection
